Access Compliance Report

Public Rights-of-Way

(Island Curb Cuts)

Intersection ID: 42513	Main Street: ELM_LN	Cross Street: INDIGO_RW	Location: NW
ADA ID: 43FFE3DE7E0A	Curb Cut Type: MedianRefuge2	Initial Pass/Fail: Pass	Overall Compliance: Yes
Codes/Mitigation Info/Possible Solution		Field Measurements/Component Compliance	
		Severity Score: 0

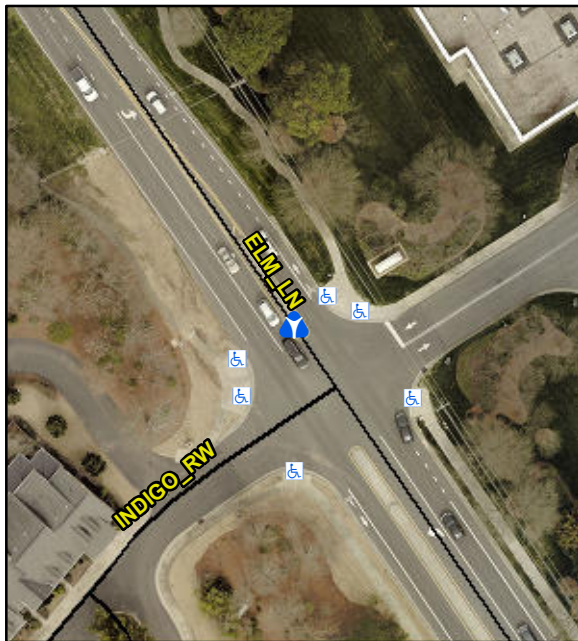
Compliance	Description	Data	Compliance	Description	Data
Yes	Refuge 1 Length (In)	36.0	Yes	Gutter 1 Ponding?	No
Yes	Refuge 1 Width (In)	96.0	Yes	Gutter 1 Lip Ht (In)	0.0
Yes	Refuge 1 Slope (%)	1.5	Yes	Gutter 1 Slope (%)	2.2
Yes	Refuge 1 X Slope (%)	0.0	Yes	Gutter 1 X Slope (%)	0.1
N/A	Painted X Walk1?	No	Yes	DWS 1 Provided?	Yes
N/A	X Walk 1 Direction	To NE	Yes	DWS 1 Contrast?	Yes
N/A	X Walk 1 Width (In)	N/A	Yes	DWS 1 Length (In)	25.0
N/A	Road 1 Slope (%)	0.4	Yes	DWS 1 Full Width?	Yes
N/A	Road 1 X Slope (%)	2.4	Yes	DWS 1 Offset (In)	0.0
Yes	Refuge 2 Length (In)	36.0	Yes	Gutter 2 Ponding?	No
Yes	Refuge 2 Width (In)	96.0	Yes	Gutter 2 Lip Ht (In)	0.0
Yes	Refuge 2 Slope (%)	0.3	Yes	Gutter 2 Slope (%)	2.0
Yes	Refuge 2 X Slope (%)	0.7	Yes	Gutter 2 X Slope (%)	1.4
N/A	Painted X Walk2?	No	Yes	DWS 2 Provided?	Yes
N/A	X Walk 2 Direction	To SW	Yes	DWS 2 Contrast?	Yes
N/A	X Walk 2 Width (In)	N/A	Yes	DWS 2 Length (In)	24.5

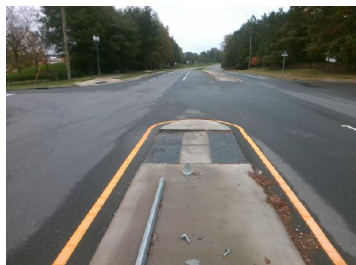
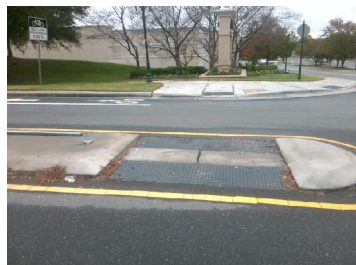
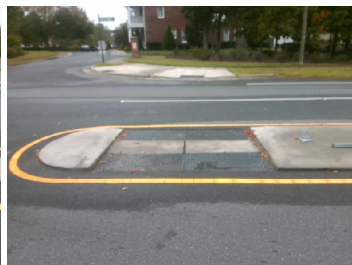
N/A	Road 2 Slope (%)	0.4	Yes	DWS 2 Full Width?	Yes
N/A	Road 2 X Slope (%)	1.4	Yes	DWS 2 Offset (In)	0.0
N/A	Refuge 3 Length (in)	N/A	N/A	Gutter 3 Ponding?	N/A
N/A	Refuge 3 Width (in)	N/A	N/A	Gutter 3 Lip Ht (in)	N/A
N/A	Refuge 3 Slope (%)	N/A	N/A	Gutter 3 Slope (%)	N/A
N/A	Refuge 3 XSlope (%)	N/A	N/A	Gutter 3 XSlope (%)	N/A
N/A	Painted X Walk3?	N/A	N/A	DWS 3 Provided?	N/A
N/A	X Walk 3 Direction	N/A	N/A	DWS 3 Contrast?	N/A
N/A	X Walk 3 Width (in)	N/A	N/A	DWS 3 Length (in)	N/A
N/A	Road 3 Slope (%)	N/A	N/A	DWS 3 Full Width?	N/A
N/A	Road 3 XSlope (%)	N/A	N/A	DWS 3 Offset (in)	N/A
Yes	Any Obstructions?	N/A	N/A	Storm Grate/Utility Hazard?	No
N/A	Obstruction Type		N/A	Storm Grate/Utility Type	
		N/A			N/A
N/A	Surface Condition	Good
