# Access Compliance Report
Public Rights-of-Way
(Curb Ramps)

Intersection ID: 18625	Main Street: FAIRFAX_DR	Cross Street: SELWYN_AV	Location:	NE
ADA ID: 9E0B0CFEBACA	Ramp Type: Perp	Initial Pass/Fail: Fail	Overall Compliance: No	Severity Score: 10

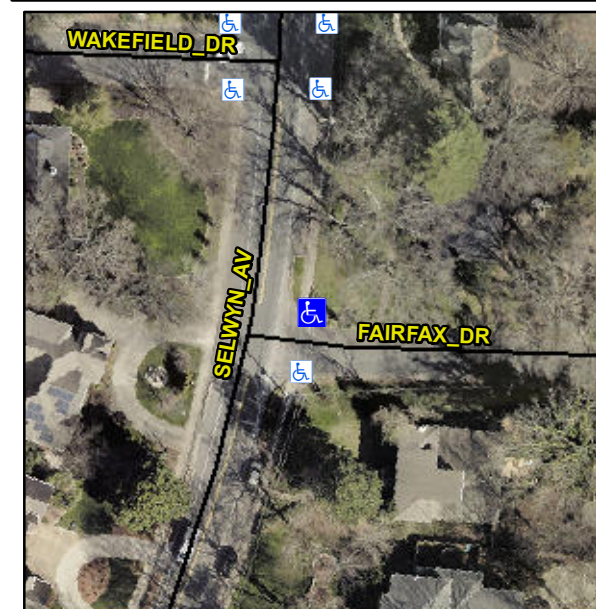
Not Found, R304.5.1

Compliance	Description	Data	Compliance	Description	Data
N/A	Ramp Length (in)	29.0	Yes	Ramp Slope (%)	8.0
No	Ramp Width (in)	38.0	Yes	Ramp XSlope (%)	2.9
N/A	Flare Type LT	N/A	N/A	Flare Type RT	N/A
N/A	Flare Slope LT (%)	N/A	N/A	Flare Slope RT (%)	N/A
N/A	Flare Traversable LT?	N/A	N/A	Flare Traversable RT?	N/A
N/A	Landing Length (in)	N/A	N/A	DWS Provided?	N/A
N/A	Landing Width (in)	N/A	N/A	DWS Contrast?	N/A
N/A	Landing Slope (%)	N/A	N/A	DWS Length (in)	N/A
N/A	Landing X Slope (%)	N/A	N/A	DWS Full Width?	N/A
N/A	Landing Curb? (Y/N)	N/A	N/A	DWS Offset (in)	N/A
N/A	Shared Landing?	N/A			
N/A	Gutter Ponding?	N/A	N/A	Gutter Slope (%)	N/A
N/A	Gutter Lip Ht (in)	N/A	N/A	Gutter X Slope (%)	N/A
N/A	Painted X Walk1?	No	N/A	Painted X Walk2?	N/A
	X Walk 1 Direction	To SW		X Walk 2 Direction	N/A
N/A	X Walk 1 Width (in)	N/A	N/A	X Walk 2 Width (in)	N/A
	X Walk 1 Slope (%)	4.3		X Walk 2 Slope (%)	N/A
	X Walk 1 X Slope (%)	3.8		X Walk 2 X Slope (%)	N/A

Remove & Replace Entire Ramp.
