Access Compliance Report

Public Rights-of-Way

(Island Curb Cuts)

| Intersection ID: 10020762 | Main Street: BEATTIES_FORD_RD | Cross Street: N/A | Location: N |

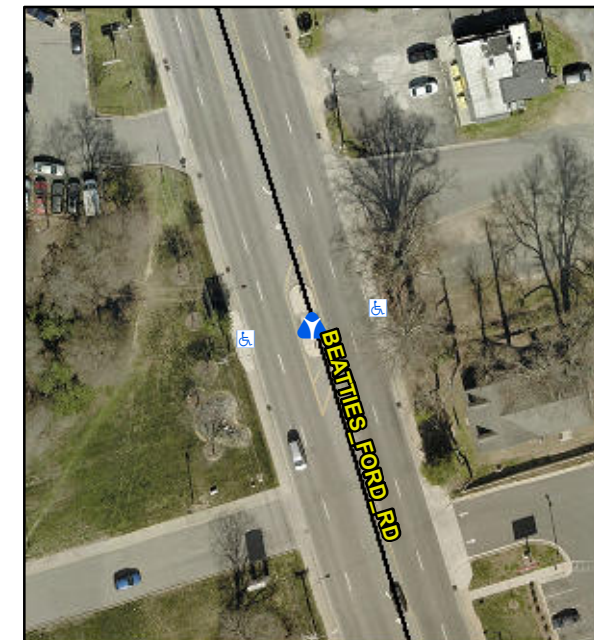
Field Measurements/Component Compliance

| Compliance | Description | Data | Compliance | Description | Data |
| Yes | Refuge 1 Length (In) | 71.5 | Yes | Gutter 1 Ponding? | No |
| Yes | Refuge 1 Width (In) | 107.0 | Yes | Gutter 1 Lip Ht (In) | 0.0 |
| Yes | Refuge 1 Slope (%) | 2.3 | Yes | Gutter 1 Slope (%) | 1.3 |
| Yes | Refuge 1 X Slope (%) | 0.1 | Yes | Gutter 1 X Slope (%) | 1.1 |
| Yes | Refuge 2 Length (In) | 71.5 | Yes | Gutter 2 Ponding? | No |
| Yes | Refuge 2 Width (In) | 107.0 | Yes | Gutter 2 Lip Ht (In) | 0.0 |
| Yes | Refuge 2 Slope (%) | 2.5 | Yes | Gutter 2 Slope (%) | 3.2 |
| Yes | Refuge 2 X Slope (%) | 1.1 | Yes | Gutter 2 X Slope (%) | 1.2 |

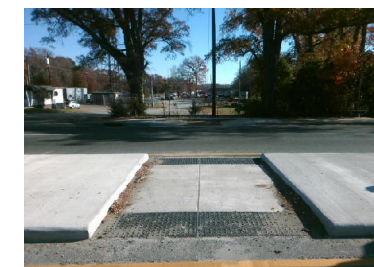
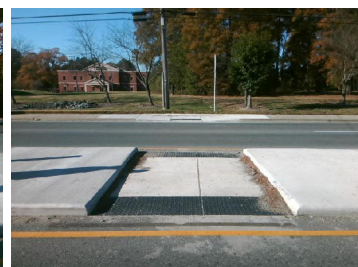
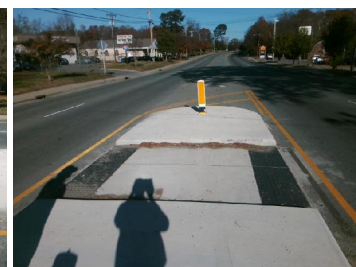
| ADA ID: 99D73C428011 | Curb Cut Type: MedianRefuge2 | Initial Pass/Fail: Pass | Overall Compliance: Yes |

| Compliance | Description | Data | Compliance | Description | Data |
|---|---|---|---|---|---|
| N/A | Surface Condition | Good | | | |
