Access Compliance Report
Public Rights-of-Way
(Curb Ramps)

Intersection ID: 45730	**Main Street:** CHESLEY_DR	**Cross Street:** PRESCOTT_HILL_AV	**Location:** SW
ADA ID: F3A3FBE59910	**Ramp Type:** PerpDiag	**Initial Pass/Fail:** Fail	**Overall Compliance:** No	**Severity Score:** 10

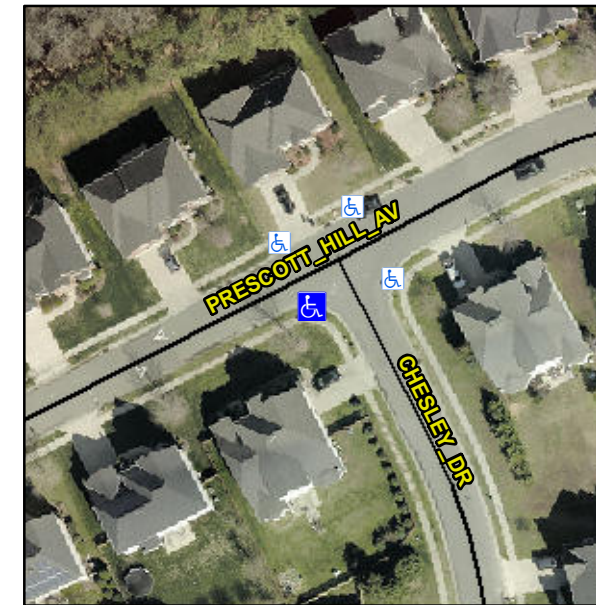
Not Found, R304.5.1, R304.5.3

Compliance	Description	Data	Compliance	Description	Data
N/A	Ramp Length (in)	50.0	Yes	Ramp Slope (%)	6.6
No	Ramp Width (in)	39.0	No	Ramp XSlope (%)	2.5
N/A	Flare Type LT	N/A	N/A	Flare Type RT	N/A
N/A	Flare Slope LT (%)	N/A	N/A	Flare Slope RT (%)	N/A
N/A	Flare Traversable LT?	N/A	N/A	Flare Traversable RT?	N/A
N/A	Landing Length (in)	N/A	N/A	DWS Provided?	N/A
N/A	Landing Width (in)	N/A	N/A	DWS Contrast?	N/A
N/A	Landing Slope (%)	N/A	N/A	DWS Length (in)	N/A
N/A	Landing X Slope (%)	N/A	N/A	DWS Full Width?	N/A
N/A	Landing Curb? (Y/N)	N/A	N/A	DWS Offset (in)	N/A
N/A	Shared Landing?	N/A			
N/A	Gutter Ponding?	N/A	N/A	Gutter Slope (%)	N/A
N/A	Gutter Lip Ht (in)	N/A	N/A	Gutter X Slope (%)	N/A
N/A	Painted X Walk1?	No	N/A	Painted X Walk2?	No
	X Walk 1 Direction	To E		X Walk 2 Direction	To N
N/A	X Walk 1 Width (in)	N/A	N/A	X Walk 2 Width (in)	N/A
	X Walk 1 Slope (%)	0.2		X Walk 2 Slope (%)	3.2
	X Walk 1 X Slope (%)	5.0		X Walk 2 X Slope (%)	0.3

Remove & Replace Curb Ramp With Two New Directional Ramps or Equivalent.
