Access Compliance Report

Public Rights-of-Way

(Island Curb Cuts)

Intersection ID: 25477	Main Street: FIVE_KNOLLS_DR	Cross Street: REA_RD	Location:	N
ADA ID: 9CD30F38EF7D	Curb Cut Type: MedianRefuge2	Initial Pass/Fail: Pass	Overall Compliance: Yes	Severity Score: 0.25

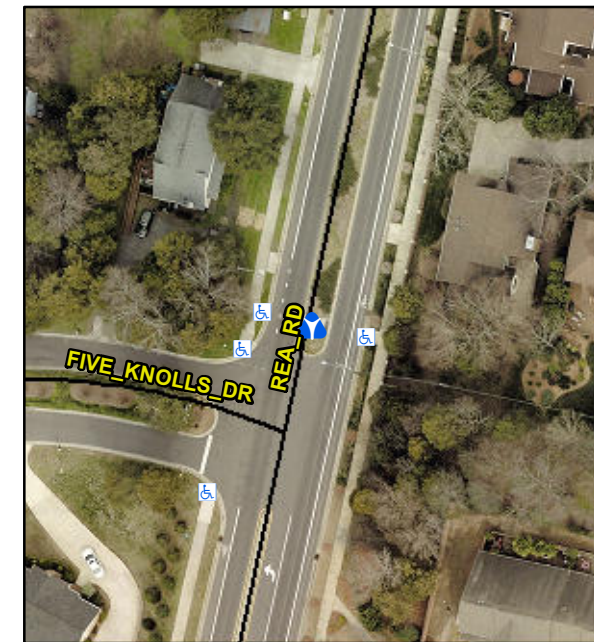
Field Measurements/Component Compliance

Compliance	Description	Data	Compliance	Description	Data
Yes	Refuge 1 Length (In)	77.5	Yes	Gutter 1 Ponding?	No
Yes	Refuge 1 Width (In)	68.0	Yes	Gutter 1 Lip Ht (In)	0.0
Yes	Refuge 1 Slope (%)	2.5	Yes	Gutter 1 Slope (%)	3.1
Yes	Refuge 1 X Slope (%)	1.5	Yes	Gutter 1 X Slope (%)	0.9
N/A	Painted X Walk1?	No	Yes	DWS 1 Provided?	Yes
N/A	X Walk 1 Direction	To W	Yes	DWS 1 Contrast?	Yes
N/A	X Walk 1 Width (In)	N/A	Yes	DWS 1 Length (In)	24.0
N/A	Road 1 Slope (%)	0.4	Yes	DWS 1 Full Width?	Yes
N/A	Road 1 X Slope (%)	0.8	Yes	DWS 1 Offset (In)	0.0
Yes	Refuge 2 Length (In)	77.5	Yes	Gutter 2 Ponding?	No
Yes	Refuge 2 Width (In)	68.0	Yes	Gutter 2 Lip Ht (In)	0.0
Yes	Refuge 2 Slope (%)	1.4	Yes	Gutter 2 Slope (%)	1.2
Yes	Refuge 2 X Slope (%)	1.7	Yes	Gutter 2 X Slope (%)	0.8
N/A	Painted X Walk2?	No	Yes	DWS 2 Provided?	Yes
N/A	X Walk 2 Direction	To E	Yes	DWS 2 Contrast?	Yes
N/A	X Walk 2 Width (In)	N/A	Yes	DWS 2 Length (In)	24.0

N/A	Road 2 Slope (%)	0.5	Yes	DWS 2 Full Width?	Yes
N/A	Road 2 X Slope (%)	2.8	Yes	DWS 2 Offset (In)	0.0
N/A	Refuge 3 Length (in)	N/A	N/A	Gutter 3 Ponding?	N/A
N/A	Refuge 3 Width (in)	N/A	N/A	Gutter 3 Lip Ht (in)	N/A
N/A	Refuge 3 Slope (%)	N/A	N/A	Gutter 3 Slope (%)	N/A
N/A	Refuge 3 XSlope (%)	N/A	N/A	Gutter 3 XSlope (%)	N/A
N/A	Painted X Walk3?	N/A	N/A	DWS 3 Provided?	N/A
N/A	X Walk 3 Direction	N/A	N/A	DWS 3 Contrast?	N/A
N/A	X Walk 3 Width (in)	N/A	N/A	DWS 3 Length (in)	N/A
N/A	Road 3 Slope (%)	N/A	N/A	DWS 3 Full Width?	N/A
N/A	Road 3 XSlope (%)	N/A	N/A	DWS 3 Offset (in)	N/A
Yes	Any Obstructions?	N/A	N/A	Storm Grate/Utility Hazard?	No
N/A	Obstruction Type		N/A	Storm Grate/Utility Type	
		N/A			N/A
N/A	Surface Condition	Good
