Access Compliance Report
Public Rights-of-Way
(Pedestrian Signals)

ADA ID: 2B19CED33981 **Signal Type:** One Push Button-APS **Overall Compliance:** No **Severity Score:** BTN 1: N/A BTN 2: N/A No BTN: N/A

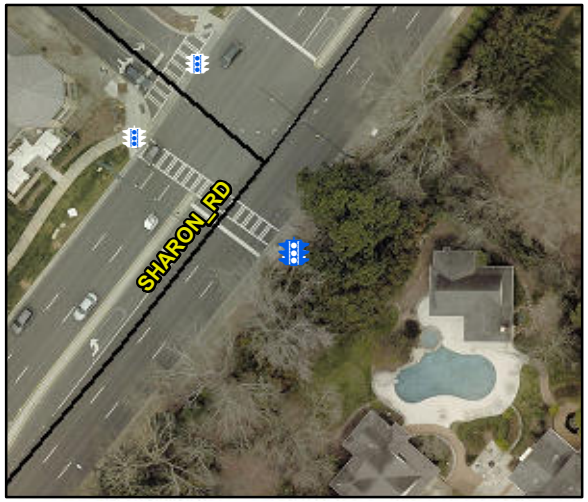
N/A	B 1 FWD Approach Width (in)	N/A	N/A	B 2 FWD Approach Width (in)	N/A
N/A	B 1 FWD Approach Obstruction?	N/A	N/A	B 2 FWD Approach Obstruction?	N/A
N/A	B 1 FWD Approach Obstruction Dist (in)	N/A	N/A	B 2 FWD Approach ObstructionDist (in)	N/A
N/A	B 1 PARA Approach?	Yes	N/A	B 2 PARA Approach?	N/A
N/A	B 1 PARA Approach Constrained?	No	N/A	B 2 PARA Approach Constrained?	N/A
No	B 1 PARA Approach Reach (in)	30.0	N/A	B 2 PARA Approach Reach (in)	N/A
N/A	B 1 PARA Approach Width (in)	N/A	N/A	B 2 PARA Approach Width (in)	N/A
N/A	B 1 PARA Approach Obstruction?	Yes	N/A	B 2 PARA Approach Obstruction?	N/A
N/A	B 1 PARA Approach Obstruction Dist (in)	23.0	N/A	B 2 PARA Approach ObstructionDist (in)	N/A
Yes	B 1 Clear Floor Space Slope (%)	0.7	N/A	B 2 Clear Floor Space Slope (%)	N/A
No	B 1 Clear Floor Space XSlope (%)	2.6	N/A	B 2 Clear Floor Space XSlope (%)	N/A
N/A	B 1 PAR Slope (%)	5.1	N/A	B 2 PAR Slope (%)	N/A
Yes	B 1 Height (in)	44.0	N/A	B 2 Height (in)	N/A

Yes	B 1 Clear Xing Direction?	ClearlyMarked	N/A	B 2 Clear Xing Direction?	N/A
	B 1 Crossing Direction	To NW		B 2 Crossing Direction	N/A
Yes	B 1 DistanceTo XWalk (in)	0.0	N/A	B 2 DistanceTo XWalk (in)	N/A
No	B 1 DistanceTo Curb (in)	88.0	N/A	B 2 DistanceTo Curb (in)	N/A
Yes	B 1 Diameter (in)	2.0	N/A	B 2 Diameter (in)	N/A

Possible Solutions: Replace Signal Push Button With APS Button on New Post. Remove & Relocate Sign.
