Access Compliance Report
Public Rights-of-Way
(Pedestrian Signals)

ADA ID: 8FF1373EDC92 | Signal Type: One Push Button-Non APS | Overall Compliance: No | Severity Score: BTN 1:N/A BTN 2: N/A No BTN: N/A

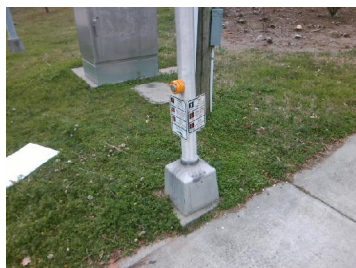
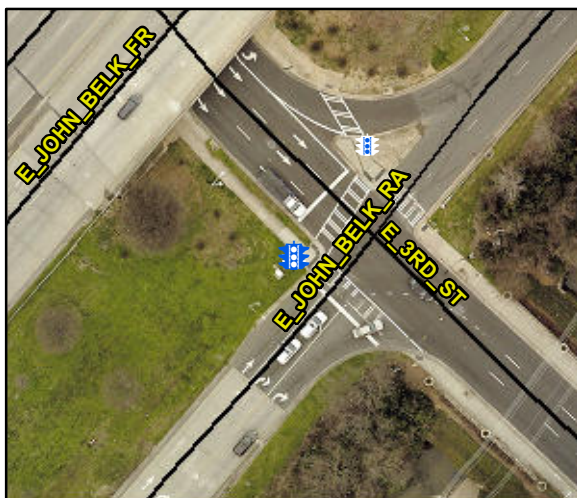
PROW/ADA: TMUTCD 4e.08, R404.2

Possible Solutions: Replace Signal Push Button With APS Button on New Post. Remove & Relocate Sign.
