Access Compliance Report

Public Rights-of-Way

(Island Curb Cuts)

Intersection ID: 44958	Main Street: N_TRYON_ST	Cross Street: OLD_CONCORD_RD	Location: E
ADA ID: EA1E75EBA0CC	Curb Cut Type: MedianRefuge2	Initial Pass/Fail: Pass	Overall Compliance: Yes
Severity Score: 0.25			
Codes/Mitigation Info/Possible Solution		Field Measurements/Component Compliance

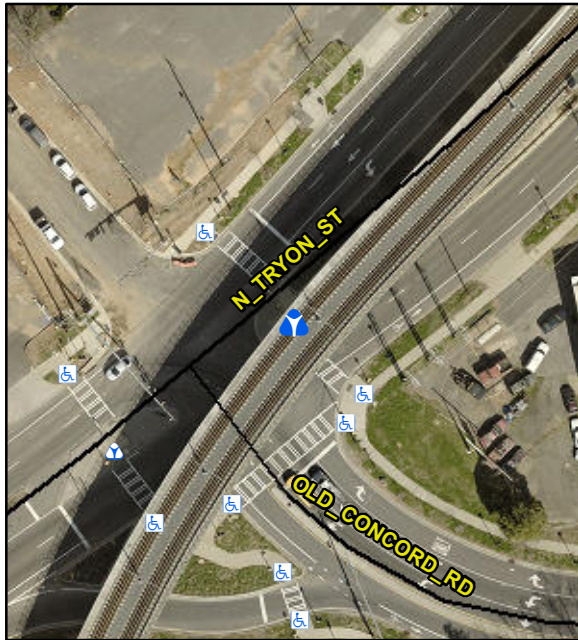
Compliance	Description	Data	Compliance	Description	Data
Yes	Refuge 1 Length (In)	69.0	Yes	Gutter 1 Ponding?	No
Yes	Refuge 1 Width (In)	104.0	Yes	Gutter 1 Lip Ht (In)	0.0
Yes	Refuge 1 Slope (%)	2.9	Yes	Gutter 1 Slope (%)	2.9
Yes	Refuge 1 X Slope (%)	1.2	Yes	Gutter 1 X Slope (%)	0.9
N/A	Painted X Walk1?	Yes	Yes	DWS 1 Provided?	Yes
N/A	X Walk 1 Direction	To S	Yes	DWS 1 Contrast?	Yes
N/A	X Walk 1 Width (In)	106.0	Yes	DWS 1 Length (In)	25.5
N/A	Road 1 Slope (%)	1.6	Yes	DWS 1 Full Width?	Yes
N/A	Road 1 X Slope (%)	2.7	Yes	DWS 1 Offset (In)	0.0
Yes	Refuge 2 Length (In)	121.0	Yes	Gutter 2 Ponding?	No
Yes	Refuge 2 Width (In)	112.0	Yes	Gutter 2 Lip Ht (In)	0.0
Yes	Refuge 2 Slope (%)	1.2	Yes	Gutter 2 Slope (%)	0.5
Yes	Refuge 2 X Slope (%)	0.5	Yes	Gutter 2 X Slope (%)	0.2
N/A	Painted X Walk2?	Yes	Yes	DWS 2 Provided?	Yes
N/A	X Walk 2 Direction	To N	Yes	DWS 2 Contrast?	Yes
N/A	X Walk 2 Width (In)	106.0	Yes	DWS 2 Length (In)	25.5
