Access Compliance Report
Public Rights-of-Way
(Pedestrian Signals)

ADA ID: 957730FA5FFC **Signal Type:** One Push Button-APS **Overall Compliance:** No **Severity Score:** BTN 1: N/A BTN 2: N/A No BTN: N/A

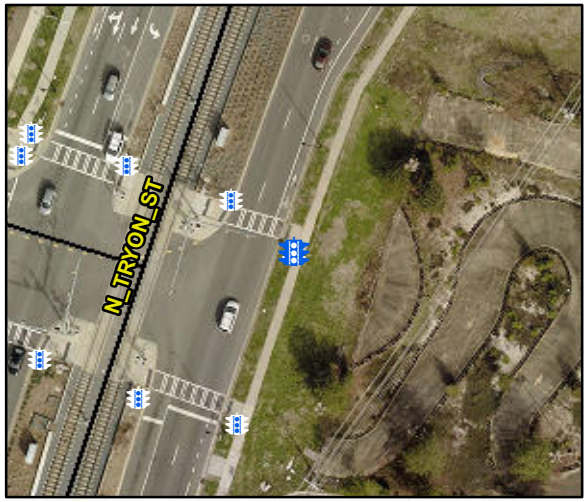
Surveyor Notes: TEXT HT 5/16

PROW/ADA: R410.6, TMUTCD 4e.08, R404.2, R404.3, R406.2, R404.7.3, R209.1, MUTCD 4e.10

Possible Solutions: Replace Signal Push Button With APS Button on New Post. Remove & Replace Sign.
