Access Compliance Report
Public Rights-of-Way
(Pedestrian Signals)

Intersection ID: N/A	Main Street:	Cross Street: N/A	Location: N/A

ADA ID: 97FF72935852	Signal Type: Two Push Buttons-Non APS	Overall Compliance: No	Severity Score: BTN 1:N/A	BTN 2: N/A	No BTN: N/A

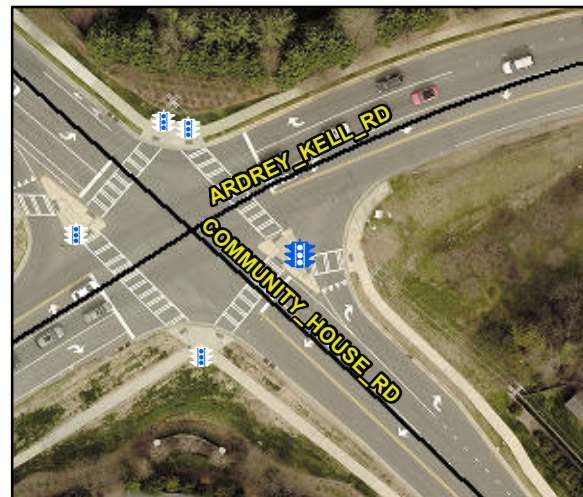
PROW/ADA: TMUTCD 4e.08, R404.7.1, R404.7.2, R404.2, R404.3

Possible Solutions: Replace Signal Push Button With APS Button on New Post. Remove & Relocate Sign.
