Access Compliance Report
Public Rights-of-Way
(Pedestrian Signals)

Intersection ID: N/A	Main Street:	Cross Street: N/A	Location: N/A

ADA ID: A7CB7A8CBC34   **Signal Type:** One Push Button-Non APS   **Overall Compliance:** No   **Severity Score: BTN 1:** N/A   **BTN 2:** N/A   **No BTN:** N/A

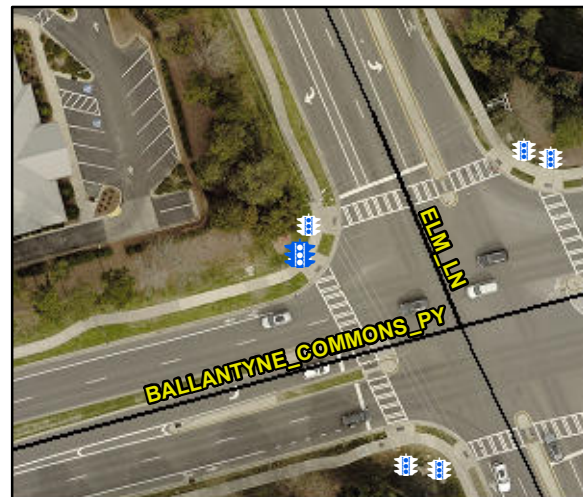
Compliance	Description	Data	Compliance	Description	Data
Yes	B 1 Clear Xing Direction?	ClearlyMarked	N/A	B 2 Clear Xing Direction?	N/A
	B 1 Crossing Direction	To SE		B 2 Crossing Direction	
Yes	B 1 DistanceTo XWalk (in)	25.0	N/A	B 2 DistanceTo XWalk (in)	N/A
No	B 1 DistanceTo Curb (in)	173.0	N/A	B 2 DistanceTo Curb (in)	N/A
Yes	B 1 Diameter (in)	2.0	N/A	B 2 Diameter (in)	N/A

Possible Solutions: Replace Signal Push Button With APS Button on New Post. Remove & Relocate Sign.
