| ADA Survey Summary | | | ADA Compliance Cost Estimate * | | | | Intersection Inventory & Compliance Cost Estimate | | | | | | | |

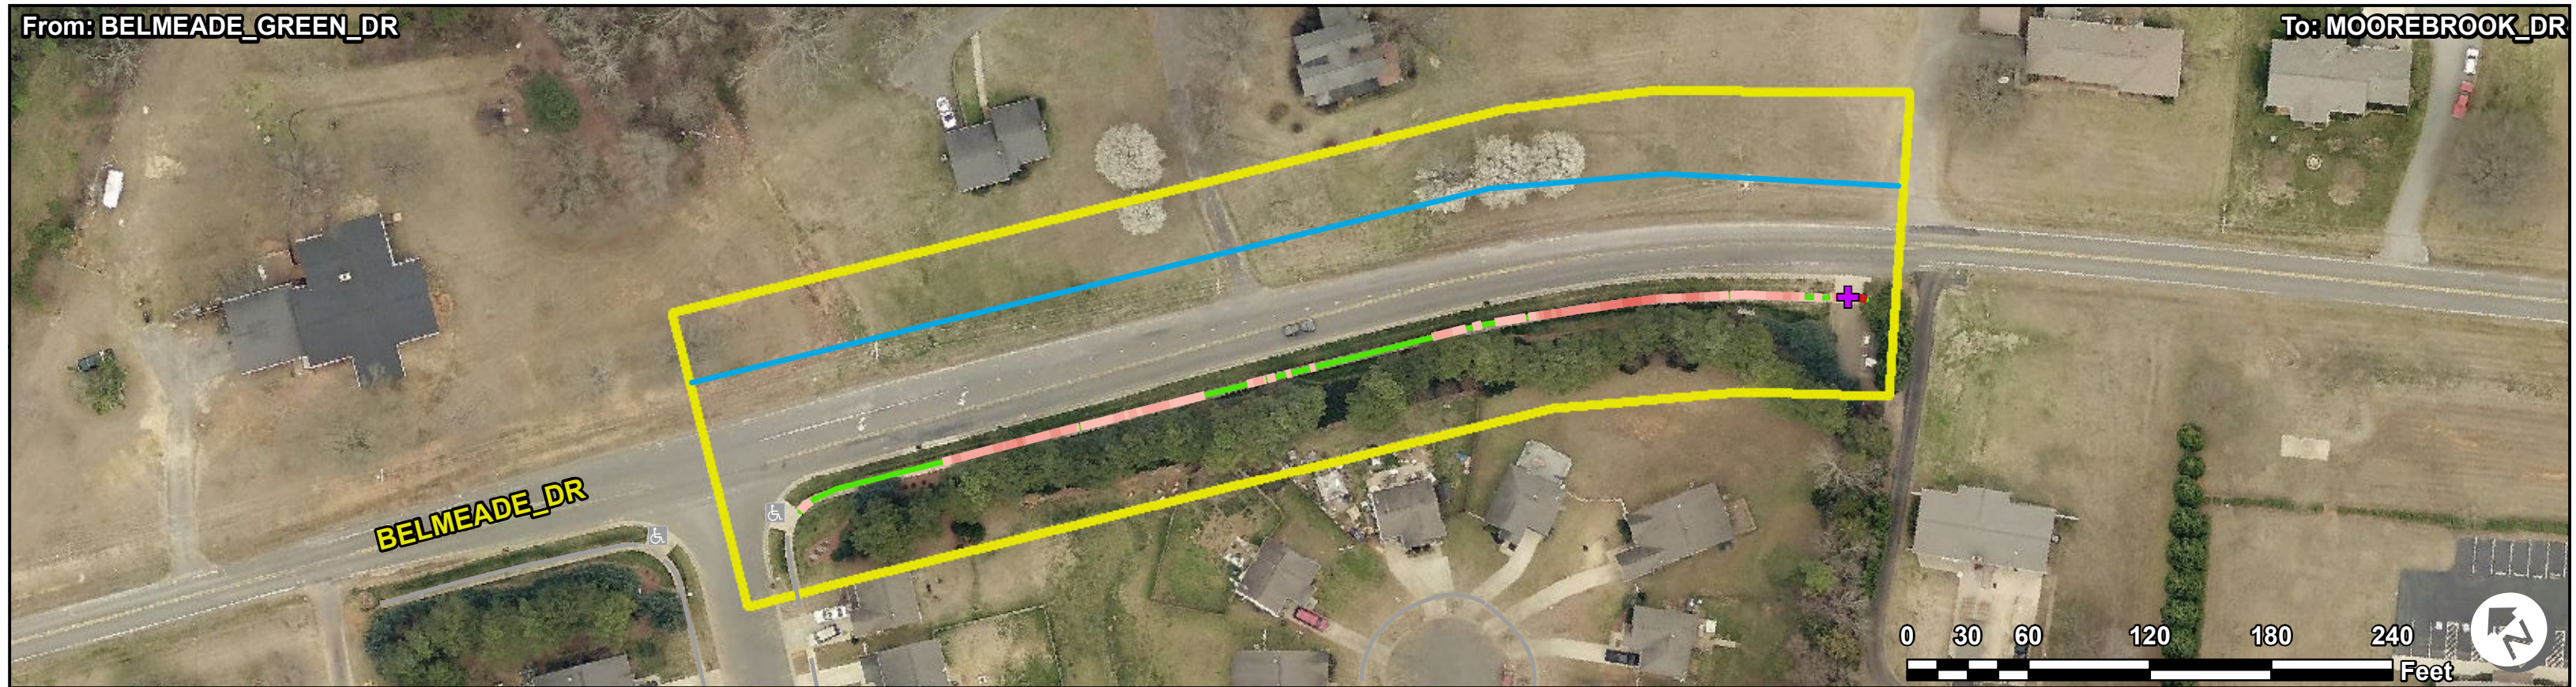
| ADA Survey Summary | | | ADA Compliance Cost Estimate * | | | | Intersection Inventory & Compliance Cost Estimate | | | | | | | |
|---|---|--|---|---|---|---|---|---|---|---|---|---|--|--|
| 1 Heavings less than 1" | 5 EA | | 1 Heavings less than 1" | 1 EA | \$ 100.00 | \$ 100.00 | Curb Ramps | 0 | 0 | \$ 0.00 | ● Heavings < 1" (Excluded)*** | ● Heavings < 1" | | |
| 20 Commercial Entrance | 1 EA | | 20 Commercial Entrance (within slope violation) | 1 EA | \$ 5000.00 | \$ 5000.00 | | | | | — Sidewalk Collection Path | | | |
| 23 Average Sidewalk Width | 48 IN | | 23 Cross Slope Violations | 150.667 SY | \$ 75.00 | \$ 11300.00 | | | | | — Sidewalk Not Surveyed | | | |

\*Note: ADA pedestrian issues have been identified and quantified in the ADA Survey Summary. There are instances where multiple issues can be resolved with a single corrective measure. The ADA Compliance Cost Estimate reflects the best estimation of quantities and cost to resolve all identified ADA issues.

\*\*\*Note: Excluded items are violations that occur in areas with slope violations and have been excluded from the cost estimate.
