| ADA Survey Summary | | | | ADA Compliance Cost Estimate * | | | | Intersection Inventory & Compliance Cost Estimate | | | | | | | |

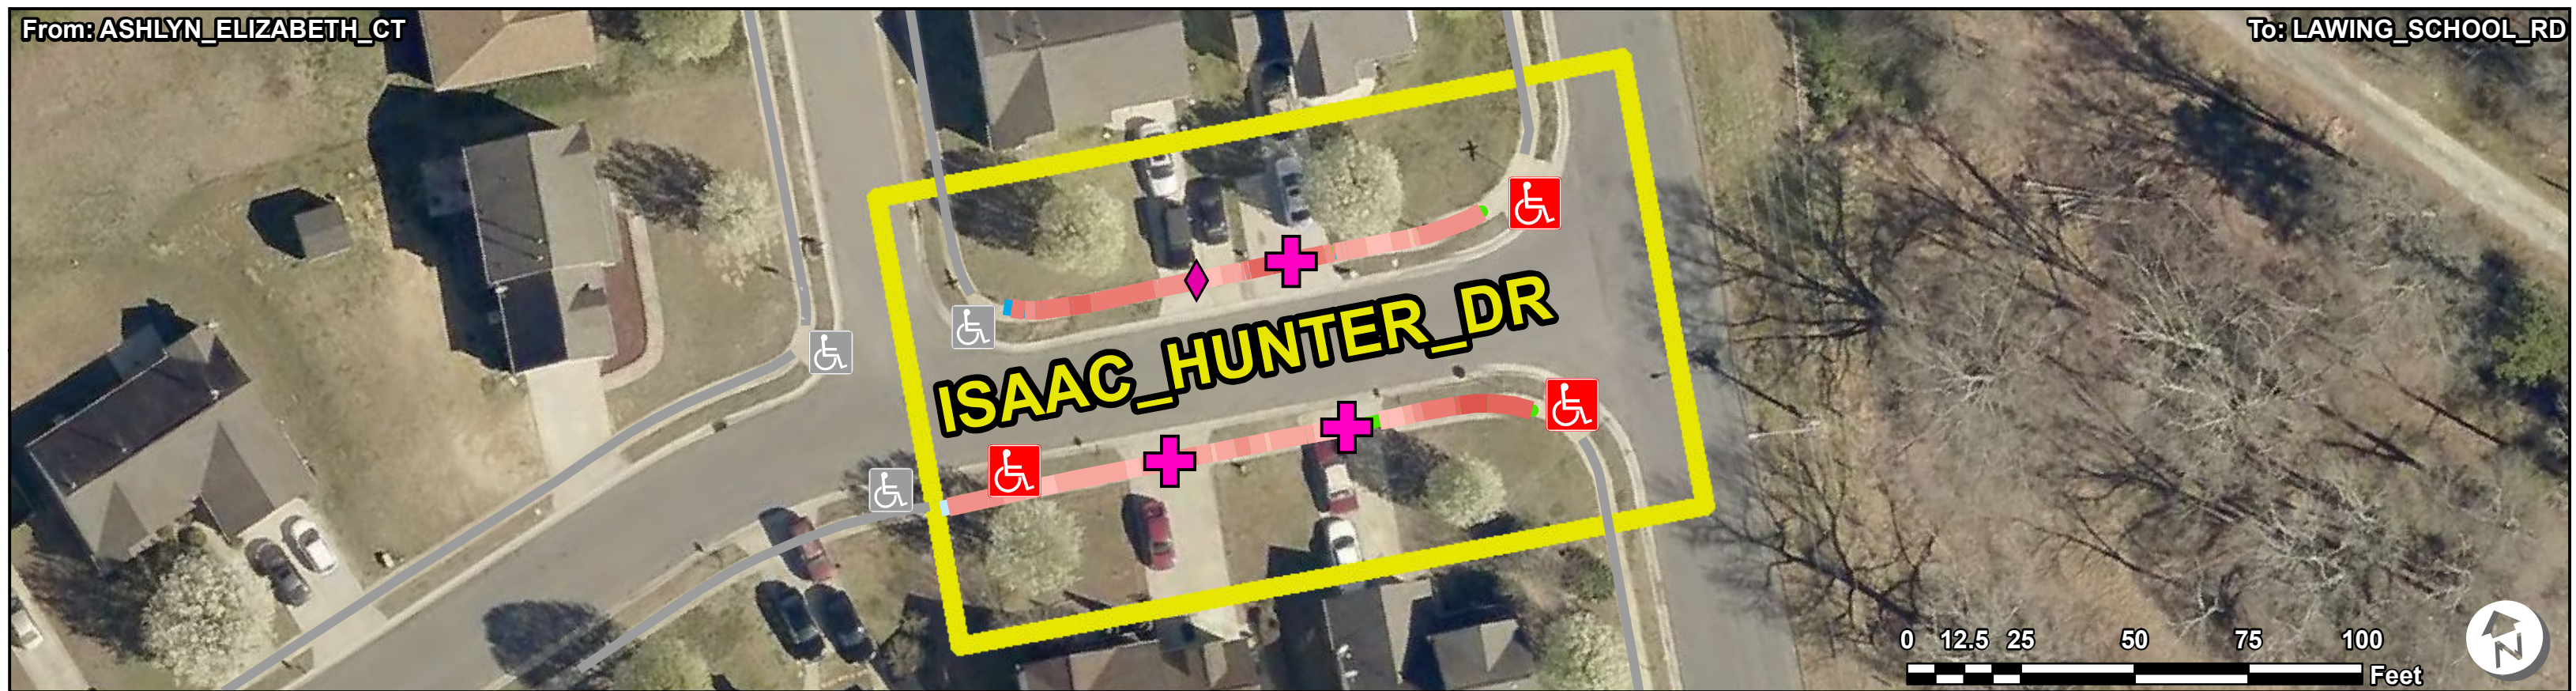
| ADA Survey Summary | | | | ADA Compliance Cost Estimate * | | | | Intersection Inventory & Compliance Cost Estimate | | | | | | | |
|---|---|---|---|---|---|---|---|---|---|---|---|--|--|--|--|
| 1 Heavings less than 1" | 3 EA | 1 Heavings less than 1" | 2 EA | \$ 100.00 | \$ 200.00 | Curb Ramps | 3 | 3 | \$ 5200.00 | ● Heavings < 1" (Excluded)*** | ● Heavings < 1" | | | | |
| 4 Heaving Clusters | 1.776 SY | 4 Heaving Clusters | 0 SY | \$ 75.00 | \$ 0.00 | Transit Stops | 0 | 0 | \$ 0.00 | — Heaving Clusters (Excluded) | — Heaving Clusters | | | | |
| 21 Residential Entrance | 4 EA | 21 Residential Entrance (within slope violation) | 3 EA | \$ 3000.00 | \$ 9000.00 | | | | | — Adjacent Sidewalk Collection Path | | | | | |
| 23 Average Sidewalk Width | 48 IN | 23 Cross Slope Violations | 38.489 SY | \$ 75.00 | \$ 2887.00 | | | | | — Sidewalk Not Surveyed | | | | | |
| 24 No Sidewalk on Block (Approx.) | 0 LF | 24 Running and Cross Slope Violations | 34.527 SY | \$ 75.00 | \$ 2590.00 | | | | | — Missing Sidewalk Gap | | | | | |

\*Note: ADA pedestrian issues have been identified and quantified in the ADA Survey Summary. There are instances where multiple issues can be resolved with a single corrective measure. The ADA Compliance Cost Estimate reflects the best estimation of quantities and cost to resolve all identified ADA issues.

\*\*\*Note: Excluded items are violations that occur in areas with slope violations and have been excluded from the cost estimate.
