Access Compliance Report

Public Rights-of-Way

(Curb Ramps)

Intersection ID: 44308	Main Street: VALERIE_DR	Cross Street: OLIVIA_DIANE_LN	Location: NW
ADA ID: 0001649E1040	Ramp Type: PerpDiag	Initial Pass/Fail: Fail	Overall Compliance: No
Severity Score: 42.5			
Codes/Mitigation Info/Possible Solution		Field Measurements/Component Compliance

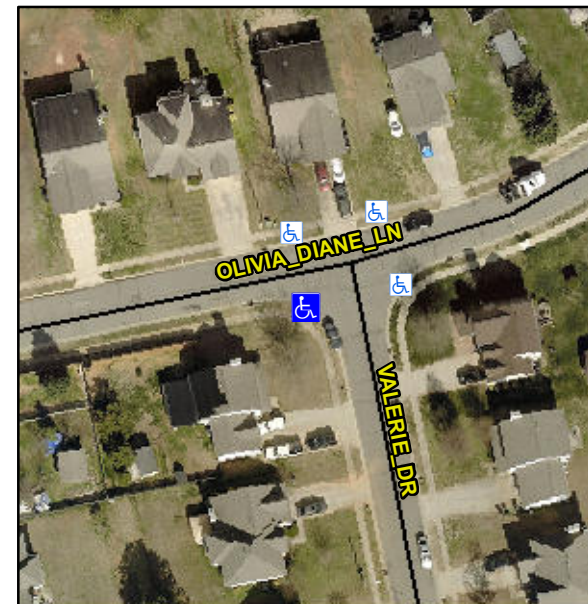
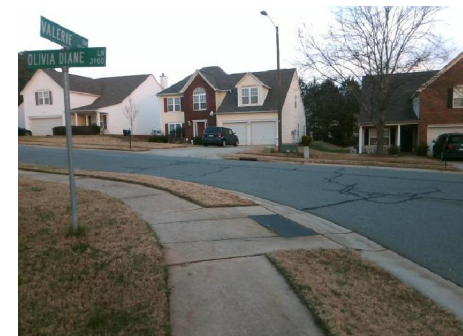
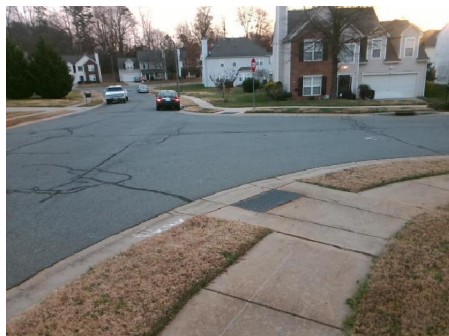
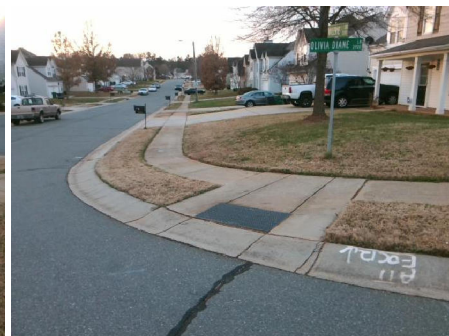
Not Found, R304.5.1, R304.5.3

Compliance	Description	Data	Compliance	Description	Data
N/A	Ramp Length (in)	95.5	Yes	Ramp Slope (%)	6.4
No	Ramp Width (in)	32.5	No	Ramp XSlope (%)	9.0
N/A	Flare Type LT	N/A	N/A	Flare Type RT	N/A
N/A	Flare Slope LT (%)	N/A	N/A	Flare Slope RT (%)	N/A
N/A	Flare Traversable LT?	N/A	N/A	Flare Traversable RT?	N/A
N/A	Landing Length (in)	N/A	N/A	DWS Provided?	N/A
N/A	Landing Width (in)	N/A	N/A	DWS Contrast?	N/A
N/A	Landing Slope (%)	N/A	N/A	DWS Length (in)	N/A
N/A	Landing X Slope (%)	N/A	N/A	DWS Full Width?	N/A
N/A	Landing Curb? (Y/N)	N/A	N/A	DWS Offset (in)	N/A
N/A	Shared Landing?	N/A			
N/A	Gutter Ponding?	N/A	N/A	Gutter Slope (%)	N/A
N/A	Gutter Lip Ht (in)	N/A	N/A	Gutter X Slope (%)	N/A
N/A	Painted X Walk1?	No	N/A	Painted X Walk2?	No
	X Walk 1 Direction	To E		X Walk 2 Direction	To N
N/A	X Walk 1 Width (in)	N/A	N/A	X Walk 2 Width (in)	N/A
	X Walk 1 Slope (%)	3.0		X Walk 2 Slope (%)	3.2
	X Walk 1 X Slope (%)	4.4		X Walk 2 X Slope (%)	5.9

N/A	Ramp inside XWalk1?	N/A	N/A	Ramp inside XWalk2?	N/A
	Road Slope (%)	6.9	N/A	Clear Space?	N/A
	Road X Slope (%)	0.1	N/A	Clear Space to XWalk (in)	N/A
N/A	Any Obstructions?	N/A	N/A	Storm Grate/Utility Hazard?	N/A
	Obstruction Type			Storm Grate/Utility Type	
		N/A			N/A
		Yes		Surface Condition? (G/P)	Good

Possible Solutions:

Remove & Replace Curb Ramp With Two New Directional Ramps or Equivalent.
