# Access Compliance Report

## Public Rights-of-Way

### (Curb Ramps)

Intersection ID: 21530	Main Street: RED_ROCK_RD	Cross Street: SARDIS_OAKS_RD	Location: SW
ADA ID: 000620C19DB3	Ramp Type: PerpDiag	Initial Pass/Fail: Fail	Overall Compliance: No
		Severity Score: 12.5

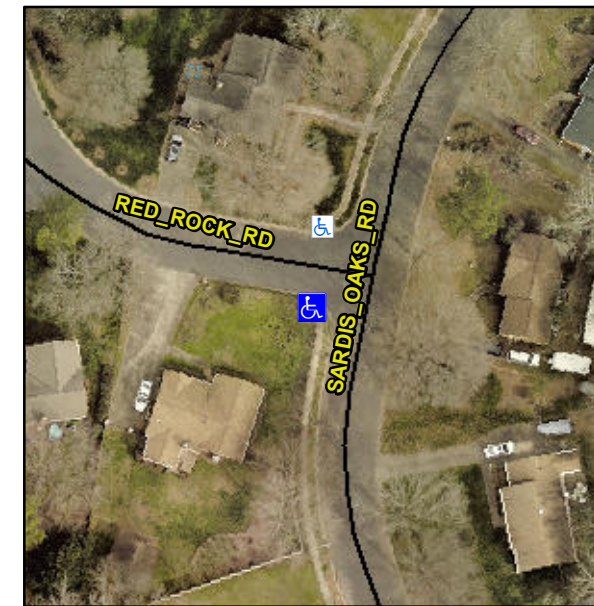
**Not Found, R304.2.2**

Compliance	Description	Data	Compliance	Description	Data
N/A	Ramp Length (in)	46.0	No	Ramp Slope (%)	9.1
Yes	Ramp Width (in)	48.0	Yes	Ramp XSlope (%)	0.7
N/A	Flare Type LT	N/A	N/A	Flare Type RT	N/A
N/A	Flare Slope LT (%)	N/A	N/A	Flare Slope RT (%)	N/A
N/A	Flare Traversable LT?	N/A	N/A	Flare Traversable RT?	N/A
N/A	Landing Length (in)	N/A	N/A	DWS Provided?	N/A
N/A	Landing Width (in)	N/A	N/A	DWS Contrast?	N/A
N/A	Landing Slope (%)	N/A	N/A	DWS Length (in)	N/A
N/A	Landing X Slope (%)	N/A	N/A	DWS Full Width?	N/A
N/A	Landing Curb? (Y/N)	N/A	N/A	DWS Offset (in)	N/A
N/A	Shared Landing?	N/A			
N/A	Gutter Ponding?	N/A	N/A	Gutter Slope (%)	N/A
N/A	Gutter Lip Ht (in)	N/A	N/A	Gutter X Slope (%)	N/A
N/A	Painted X Walk1?	No	N/A	Painted X Walk2?	No
	X Walk 1 Direction	To SE		X Walk 2 Direction	To NE
N/A	X Walk 1 Width (in)	N/A	N/A	X Walk 2 Width (in)	N/A
	X Walk 1 Slope (%)	5.0		X Walk 2 Slope (%)	5.4
	X Walk 1 X Slope (%)	3.0		X Walk 2 X Slope (%)	1.4

N/A	Ramp inside XWalk1?	N/A	N/A	Ramp inside XWalk2?	N/A
	Road Slope (%)	0.4	N/A	Clear Space?	N/A
	Road X Slope (%)	7.1	N/A	Clear Space to XWalk (in)	N/A
N/A	Any Obstructions?	N/A	N/A	Storm Grate/Utility Hazard?	N/A
	Obstruction Type			Storm Grate/Utility Type	
		N/A			N/A
			Yes	Surface Condition? (G/P)	Good

**Remove & Replace Curb Ramp With Two New Directional Ramps or Equivalent.**

Total Cost: \$ 3200.00
