Access Compliance Report

Public Rights-of-Way

(Curb Ramps)

Intersection ID: 3933	Main Street: BERSHIRE_LN	Cross Street: LIONSTONE_DR	Location: SW
ADA ID: 0008114F6E45	Ramp Type: Perp	Initial Pass/Fail: Fail	Overall Compliance: No
			Severity Score: 26.25

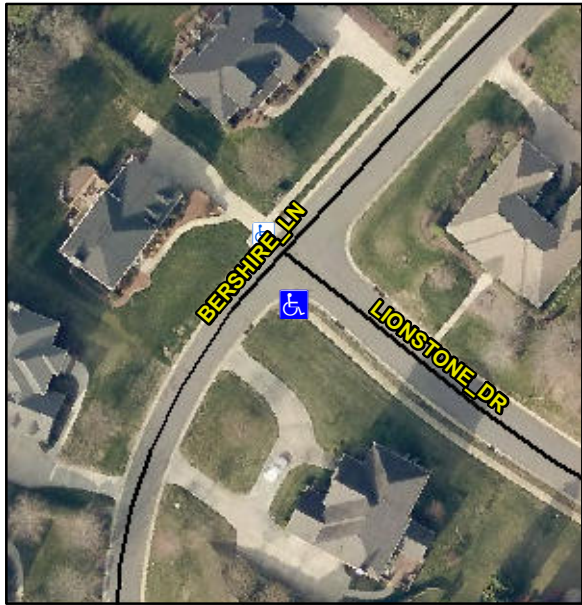
Possible Solutions:		Compliance	Description	Data	Compliance	Description	Data
	Remove & Replace Entire Ramp.		N/A	Ramp Length (in)	46.0	No	Ramp Slope (%)	14.7
			Yes	Ramp Width (in)	51.0	No	Ramp XSlope (%)	4.2
			N/A	Flare Type LT	N/A	N/A	Flare Type RT	N/A
			N/A	Flare Slope LT (%)	N/A	N/A	Flare Slope RT (%)	N/A
			N/A	Flare Traversable LT?	N/A	N/A	Flare Traversable RT?	N/A
			N/A	Landing Length (in)	N/A	N/A	DWS Provided?	N/A
			N/A	Landing Width (in)	N/A	N/A	DWS Contrast?	N/A
			N/A	Landing Slope (%)	N/A	N/A	DWS Length (in)	N/A
			N/A	Landing X Slope (%)	N/A	N/A	DWS Full Width?	N/A
Surveyor Notes:		N/A	N/A	Landing Curb? (Y/N)	N/A	N/A	DWS Offset (in)	N/A
PROW/ADA:		Not Found, R304.2.2, R304.5.3	N/A	Shared Landing?	N/A			
			N/A	Gutter Ponding?	N/A	N/A	Gutter Slope (%)	N/A
			N/A	Gutter Lip Ht (in)	N/A	N/A	Gutter X Slope (%)	N/A

N/A	Painted X Walk1?	No	N/A	Painted X Walk2?	N/A
				X Walk 1 Direction	To SE		X Walk 2 Direction	N/A
			N/A	X Walk 1 Width (in)	N/A	N/A	X Walk 2 Width (in)	N/A
				X Walk 1 Slope (%)	0.7		X Walk 2 Slope (%)	N/A
				X Walk 1 X Slope (%)	3.1		X Walk 2 X Slope (%)	N/A
			N/A	Ramp inside XWalk1?	N/A	N/A	Ramp inside XWalk2?	N/A
				Road Slope (%)	N/A	N/A	Clear Space?	N/A
				Road X Slope (%)	N/A	N/A	Clear Space to XWalk (in)	N/A
			N/A	Any Obstructions?	N/A	N/A	Storm Grate/Utility Hazard?	N/A
				Obstruction Type			Storm Grate/Utility Type	
					N/A			N/A
						Yes	Surface Condition? (G/P)	Good
Street 1 Name		LIONSTONE DR						
Stop Condition-Street 2		StopSign						
Street 2 Name		N/A						
Stop Condition-Street 1		N/A						
Total Cost:		\$ 1850.00
