Access Compliance Report

Public Rights-of-Way

(Curb Ramps)

Intersection ID: 49251	Main Street: RIDGE_PATH_LN	Cross Street: PROSPERITY_RIDGE_RD	Location:	N
ADA ID: 001E971E889D	Ramp Type: Perp	Initial Pass/Fail: Pass	Overall Compliance: No	Severity Score: 7.75
Codes/Mitigation Info/Possible Solution		Field Measurements/Component Compliance

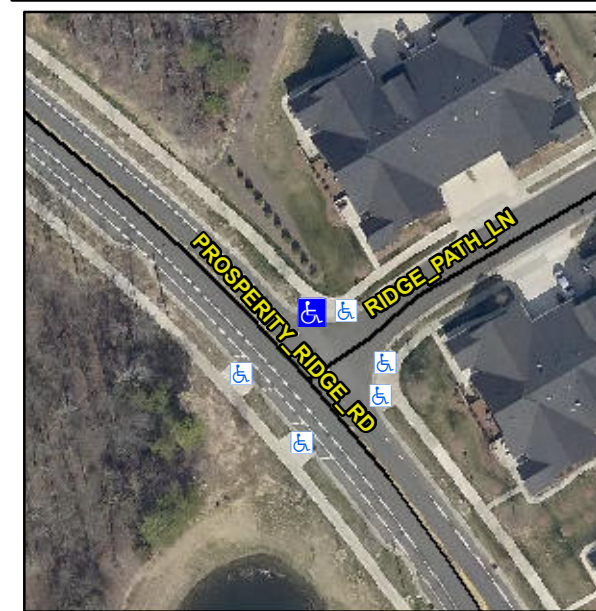
Compliance	Description	Data	Compliance	Description	Data
N/A	Ramp Length (in)	75.0	Yes	Ramp Slope (%)	6.1
Yes	Ramp Width (in)	48.0	No	Ramp XSlope (%)	2.9
N/A	Flare Type LT	Sloped	N/A	Flare Type RT	N/A
N/A	Flare Slope LT (%)	9.6	Yes	Flare Slope RT (%)	2.6
N/A	Flare Traversable LT?	Yes	N/A	Flare Traversable RT?	Yes
Yes	Landing Length (in)	70.0	Yes	DWS Provided?	Yes
Yes	Landing Width (in)	48.0	Yes	DWS Contrast?	Yes
Yes	Landing Slope (%)	1.7	Yes	DWS Length (in)	24.0
No	Landing X Slope (%)	3.0	Yes	DWS Full Width?	Yes
N/A	Landing Curb? (Y/N)	No	Yes	DWS Offset (in)	1.0
N/A	Shared Landing?	No			
Yes	Gutter Ponding?	No	Yes	Gutter Slope (%)	2.8
No	Gutter Lip Ht (in)	0.5	No	Gutter X Slope (%)	2.3
N/A	Painted X Walk1?	No	N/A	Painted X Walk2?	N/A
	X Walk 1 Direction	To SW		X Walk 2 Direction	N/A
N/A	X Walk 1 Width (in)	N/A	N/A	X Walk 2 Width (in)	N/A
	X Walk 1 Slope (%)	2.5		X Walk 2 Slope (%)	N/A
	X Walk 1 X Slope (%)	1.8		X Walk 2 X Slope (%)	N/A

N/A	Ramp inside XWalk1?	N/A	N/A	Ramp inside XWalk2?	N/A
	Road Slope (%)	N/A	N/A	Clear Space?	Yes
	Road X Slope (%)	N/A	N/A	Clear Space to XWalk (in)	N/A
Yes	Any Obstructions?	No	Yes	Storm Grate/Utility Hazard?	No
	Obstruction Type			Storm Grate/Utility Type	
		N/A			N/A
			Yes	Surface Condition? (G/P)	Good

Possible Solutions:

**Remove & Replace Entire Ramp.
Remove & Replace Gutter.**

PROW/ADA:

R304.5.3, R302.7.2
