| Intersection ID: 5855 | Main Street: W_SUGAR_CREEK_RD | Cross Street: NEVIN_RD | Location: | NW |
| ADA ID: 003959AB6359 | Ramp Type: PerpDiag | Initial Pass/Fail: Fail | Overall Compliance: No | Severity Score: 13.75 |

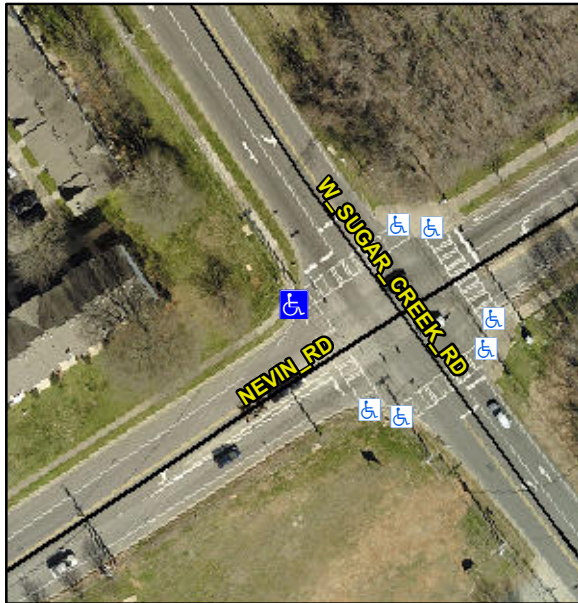
**Not Found, R304.2.2**

| Compliance | Description | Data | Compliance | Description | Data |
|---|---|---|---|---|---|
| N/A | Ramp Length (in) | 54.0 | No | Ramp Slope (%) | 9.1 |
| Yes | Ramp Width (in) | 50.5 | Yes | Ramp XSlope (%) | 2.7 |

**Remove & Replace Curb Ramp With Two New Directional Ramps or Equivalent.**

Total Cost: \$ 3200.00
