Access Compliance Report

Public Rights-of-Way

(Curb Ramps)

Intersection ID: 14429	Main Street: LEAKE_ST	Cross Street: WEST_BV	Location: NW
ADA ID: 003AF1F5CA8F	Ramp Type: PerpDiag	Initial Pass/Fail: Fail	Overall Compliance: No
Severity Score: 13.75			
Codes/Mitigation Info/Possible Solution		Field Measurements/Component Compliance

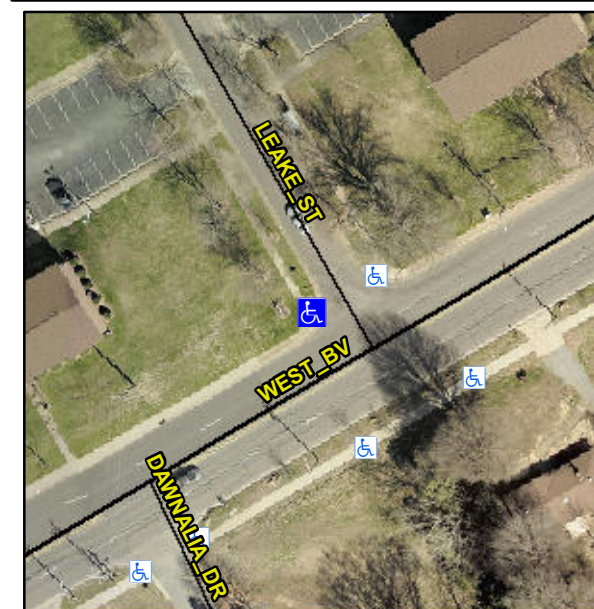
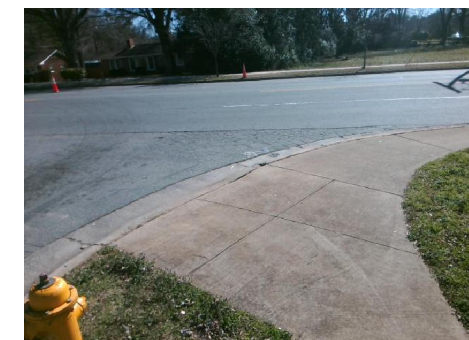
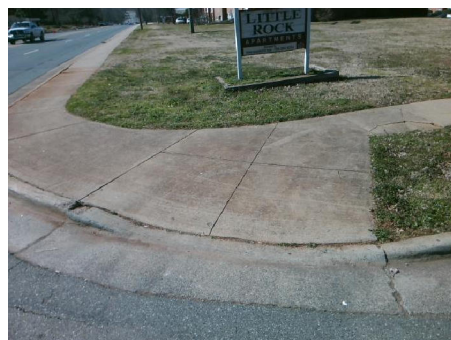
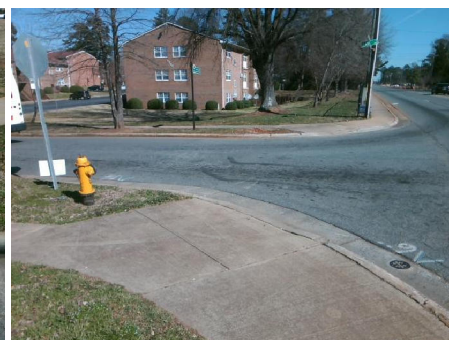
Compliance	Description	Data	Compliance	Description	Data
N/A	Ramp Length (in)	55.0	No	Ramp Slope (%)	9.7
Yes	Ramp Width (in)	48.0	No	Ramp XSlope (%)	2.2
N/A	Flare Type LT	N/A	N/A	Flare Type RT	N/A
N/A	Flare Slope LT (%)	N/A	N/A	Flare Slope RT (%)	N/A
N/A	Flare Traversable LT?	N/A	N/A	Flare Traversable RT?	N/A
N/A	Landing Length (in)	N/A	N/A	DWS Provided?	N/A
N/A	Landing Width (in)	N/A	N/A	DWS Contrast?	N/A
N/A	Landing Slope (%)	N/A	N/A	DWS Length (in)	N/A
N/A	Landing X Slope (%)	N/A	N/A	DWS Full Width?	N/A
N/A	Landing Curb? (Y/N)	N/A	N/A	DWS Offset (in)	N/A
N/A	Shared Landing?	N/A			
N/A	Gutter Ponding?	N/A	N/A	Gutter Slope (%)	N/A
N/A	Gutter Lip Ht (in)	N/A	N/A	Gutter X Slope (%)	N/A
N/A	Painted X Walk1?	No	N/A	Painted X Walk2?	No
	X Walk 1 Direction	To S		X Walk 2 Direction	To E
N/A	X Walk 1 Width (in)	N/A	N/A	X Walk 2 Width (in)	N/A
	X Walk 1 Slope (%)	2.4		X Walk 2 Slope (%)	3.9
	X Walk 1 X Slope (%)	2.6		X Walk 2 X Slope (%)	0.2

N/A	Ramp inside XWalk1?	N/A	N/A	Ramp inside XWalk2?	N/A
	Road Slope (%)	1.6	N/A	Clear Space?	N/A
	Road X Slope (%)	4.7	N/A	Clear Space to XWalk (in)	N/A
N/A	Any Obstructions?	N/A	N/A	Storm Grate/Utility Hazard?	N/A
	Obstruction Type			Storm Grate/Utility Type	
		N/A			N/A
		Yes		Surface Condition? (G/P)	Good

Possible Solutions:

Remove & Replace Curb Ramp With Two New Directional Ramps or Equivalent.
