Access Compliance Report

Public Rights-of-Way

(Curb Ramps)

Intersection ID: 10037292	Main Street: SARDIS_RD	Cross Street: N/A	Location: S
ADA ID: 003CCD1F9A4D	Ramp Type: PerpDiag	Initial Pass/Fail: Fail	Overall Compliance: No
Severity Score: 13.75			
Codes/Mitigation Info/Possible Solution		Field Measurements/Component Compliance

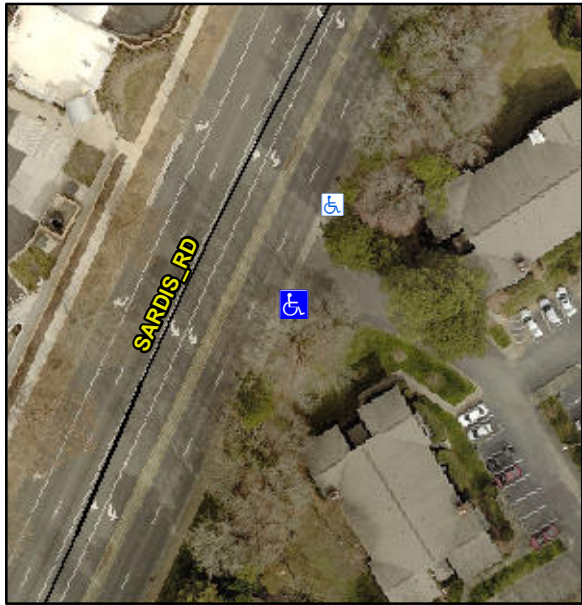
Possible Solutions:		Compliance		Description	Data	Compliance	Description	Data
	Remove & Replace Curb Ramp With Two New Directional Ramps or Equivalent.		N/A	Ramp Length (in)	58.0	No	Ramp Slope (%)	11.7	
			Yes	Ramp Width (in)	48.0	No	Ramp XSlope (%)	5.0	
			N/A	Flare Type LT	N/A	N/A	Flare Type RT	N/A	
			N/A	Flare Slope LT (%)	N/A	N/A	Flare Slope RT (%)	N/A	
			N/A	Flare Traversable LT?	N/A	N/A	Flare Traversable RT?	N/A	
			N/A	Landing Length (in)	N/A	N/A	DWS Provided?	N/A	
			N/A	Landing Width (in)	N/A	N/A	DWS Contrast?	N/A	
			N/A	Landing Slope (%)	N/A	N/A	DWS Length (in)	N/A	
			N/A	Landing X Slope (%)	N/A	N/A	DWS Full Width?	N/A	
Surveyor Notes:		N/A	N/A	Landing Curb? (Y/N)	N/A	N/A	DWS Offset (in)	N/A	
PROW/ADA:		Not Found, R304.2.2, R304.5.3		N/A	Shared Landing?	N/A			
				N/A	Gutter Ponding?	N/A	N/A	Gutter Slope (%)	N/A
				N/A	Gutter Lip Ht (in)	N/A	N/A	Gutter X Slope (%)	N/A
				N/A	Painted X Walk1?	No	N/A	Painted X Walk2?	No

X Walk 1 Direction	To NE		X Walk 2 Direction	To NW
				N/A	X Walk 1 Width (in)	N/A	N/A	X Walk 2 Width (in)	N/A
					X Walk 1 Slope (%)	1.9		X Walk 2 Slope (%)	0.5
					X Walk 1 X Slope (%)	1.3		X Walk 2 X Slope (%)	2.5
				N/A	Ramp inside XWalk1?	N/A	N/A	Ramp inside XWalk2?	N/A
					Road Slope (%)	3.1	N/A	Clear Space?	N/A
					Road X Slope (%)	1.6	N/A	Clear Space to XWalk (in)	N/A
				N/A	Any Obstructions?	N/A	N/A	Storm Grate/Utility Hazard?	N/A
					Obstruction Type			Storm Grate/Utility Type	
							N/A		N/A
							Yes	Surface Condition? (G/P)	Good
