Access Compliance Report Public Rights-of-Way (Curb Ramps)

Intersection ID: N/A Main Street: WHITNEY_HILL_RD Cross Street: N/A Location: W

ADA ID: 0057EC5D8386 Ramp Type: Perp Initial Pass/Fail: Pass Overall Compliance: No Severity Score: 25.25

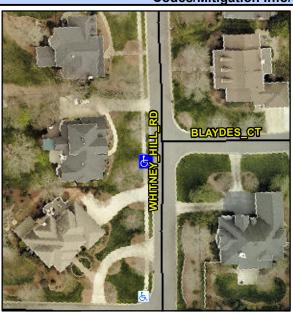
Street 1 Name WHITNEY HILL RD
Stop Condition-Street 2 None
Street 2 Name N/A
Stop Condition-Street 1 N/A

Not Found, R304.5.3, R304.2.1,
R304.2.2-Perp, R304.3.2-Para, R305,
R304.5.4

| Field Measurements/Component Compliance | | | | | |
|---|---|---|---|---|---|
| N/A | Ramp Length (in) | 94.0 | Yes | Ramp Slope (%) | 6.8 |
| Yes | Ramp Width (in) | 67.5 | No | Ramp XSlope (%) | 3.1 |
| No | Landing Length (in) | N/A | No | DWS Provided? | No |
| Yes | Gutter Ponding? | No | No | Gutter Slope (%) | 6.2 |

Remove & Replace Entire Ramp.
Remove & Replace Gutter.

Total Cost: \$ 2600.00
