# Access Compliance Report

## Public Rights-of-Way

| Intersection ID: 15599 | Main Street: COLVILLE_RD | Cross Street: EASTOVER_RD | Location: NE |
| ADA ID: 006007AA9AEB | Ramp Type: Perp | Initial Pass/Fail: Fail | Overall Compliance: No |

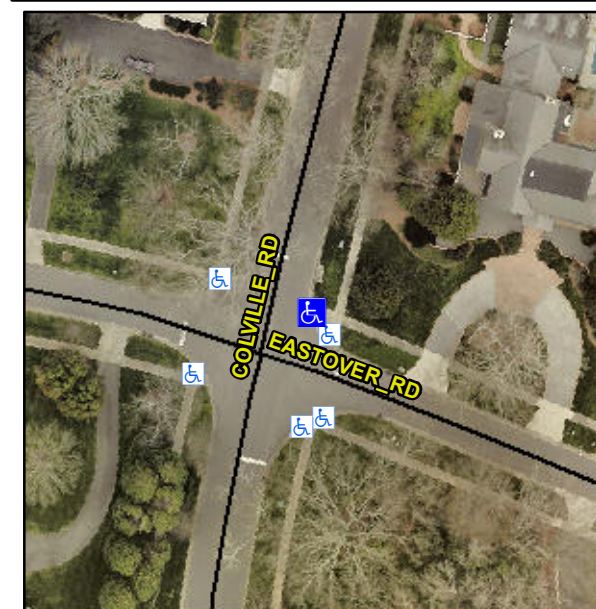
| Severity Score: 13.75 | | | |

**Not Found, R304.2.2, R304.5.3**

| Compliance | Description | Data | Compliance | Description | Data |
|---|---|---|---|---|---|
| N/A | Ramp Length (in) | 48.0 | No | Ramp Slope (%) | 9.4 |
| Yes | Ramp Width (in) | 48.0 | No | Ramp XSlope (%) | 4.0 |

**Remove & Replace Entire Ramp.**
