Access Compliance Report

Public Rights-of-Way

(Curb Ramps)

Intersection ID: 10878	Main Street: SPRATT_ST	Cross Street: SPRATT_ST	Location: NW
ADA ID: 006027738D98	Ramp Type: Perp	Initial Pass/Fail: Fail	Overall Compliance: No
Severity Score: 10			
Codes/Mitigation Info/Possible Solution		Field Measurements/Component Compliance

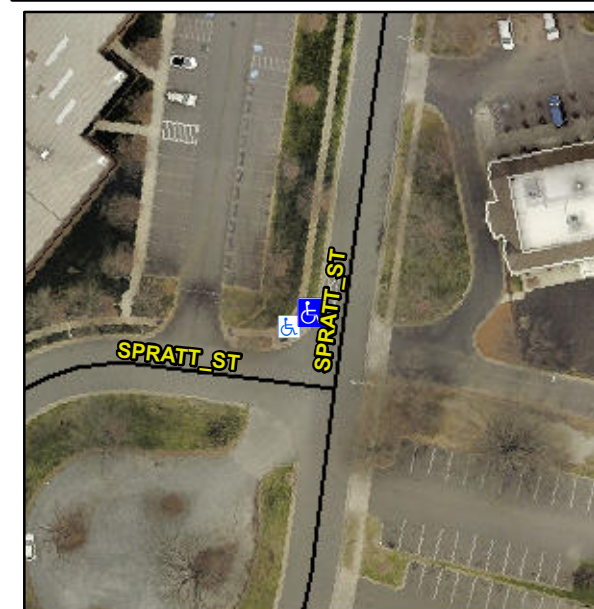
Not Found, R304.5.1, R304.5.3

Compliance	Description	Data	Compliance	Description	Data
N/A	Ramp Length (in)	63.0	Yes	Ramp Slope (%)	7.1
No	Ramp Width (in)	47.0	No	Ramp XSlope (%)	3.9
N/A	Flare Type LT	N/A	N/A	Flare Type RT	N/A
N/A	Flare Slope LT (%)	N/A	N/A	Flare Slope RT (%)	N/A
N/A	Flare Traversable LT?	N/A	N/A	Flare Traversable RT?	N/A
N/A	Landing Length (in)	N/A	N/A	DWS Provided?	N/A
N/A	Landing Width (in)	N/A	N/A	DWS Contrast?	N/A
N/A	Landing Slope (%)	N/A	N/A	DWS Length (in)	N/A
N/A	Landing X Slope (%)	N/A	N/A	DWS Full Width?	N/A
N/A	Landing Curb? (Y/N)	N/A	N/A	DWS Offset (in)	N/A
N/A	Shared Landing?	N/A			
N/A	Gutter Ponding?	N/A	N/A	Gutter Slope (%)	N/A
N/A	Gutter Lip Ht (in)	1.5	N/A	Gutter X Slope (%)	N/A
N/A	Painted X Walk1?	No	N/A	Painted X Walk2?	N/A
	X Walk 1 Direction	To E		X Walk 2 Direction	N/A
N/A	X Walk 1 Width (in)	N/A	N/A	X Walk 2 Width (in)	N/A
	X Walk 1 Slope (%)	1.7		X Walk 2 Slope (%)	N/A
	X Walk 1 X Slope (%)	3.5		X Walk 2 X Slope (%)	N/A

N/A	Ramp inside XWalk1?	N/A	N/A	Ramp inside XWalk2?	N/A
	Road Slope (%)	N/A	N/A	Clear Space?	N/A
	Road X Slope (%)	N/A	N/A	Clear Space to XWalk (in)	N/A
N/A	Any Obstructions?	N/A	N/A	Storm Grate/Utility Hazard?	N/A
	Obstruction Type			Storm Grate/Utility Type	
		N/A			N/A
			Yes	Surface Condition? (G/P)	Good

Possible Solutions:

Remove & Replace Entire Ramp.
