# Access Compliance Report

## Public Rights-of-Way

### (Curb Ramps)

Intersection ID: 8040	Main Street: STATESVILLE_AV	Cross Street: ALMA_CT	Location: NW
ADA ID: 0063E3EF7849	Ramp Type: PerpDiag	Initial Pass/Fail: Fail	Overall Compliance: No
		Severity Score: 22.5

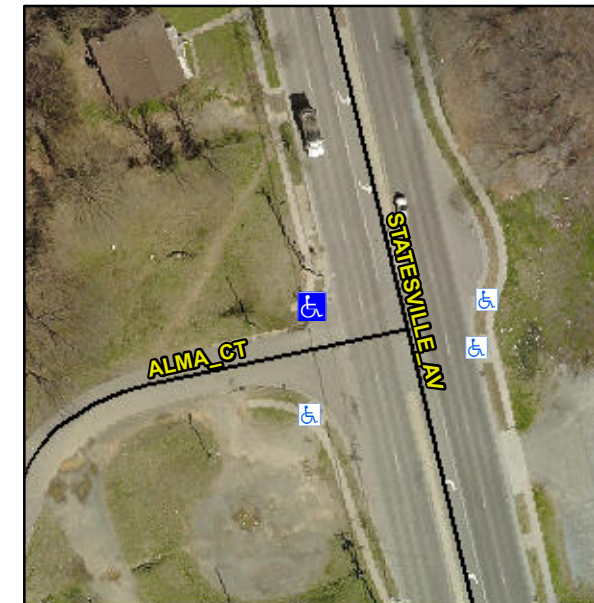
**Not Found, R304.5.1, R304.2.2, R304.5.3**

Compliance	Description	Data	Compliance	Description	Data
N/A	Ramp Length (in)	59.5	No	Ramp Slope (%)	9.5
No	Ramp Width (in)	38.0	No	Ramp XSlope (%)	4.7
N/A	Flare Type LT	N/A	N/A	Flare Type RT	N/A
N/A	Flare Slope LT (%)	N/A	N/A	Flare Slope RT (%)	N/A
N/A	Flare Traversable LT?	N/A	N/A	Flare Traversable RT?	N/A
N/A	Landing Length (in)	N/A	N/A	DWS Provided?	N/A
N/A	Landing Width (in)	N/A	N/A	DWS Contrast?	N/A
N/A	Landing Slope (%)	N/A	N/A	DWS Length (in)	N/A
N/A	Landing X Slope (%)	N/A	N/A	DWS Full Width?	N/A
N/A	Landing Curb? (Y/N)	N/A	N/A	DWS Offset (in)	N/A
N/A	Shared Landing?	N/A			
N/A	Gutter Ponding?	N/A	N/A	Gutter Slope (%)	N/A
N/A	Gutter Lip Ht (in)	N/A	N/A	Gutter X Slope (%)	N/A
N/A	Painted X Walk1?	No	N/A	Painted X Walk2?	No
	X Walk 1 Direction	To S		X Walk 2 Direction	To E
N/A	X Walk 1 Width (in)	N/A	N/A	X Walk 2 Width (in)	N/A
	X Walk 1 Slope (%)	1.5		X Walk 2 Slope (%)	0.7
	X Walk 1 X Slope (%)	0.2		X Walk 2 X Slope (%)	4.5

N/A	Ramp inside XWalk1?	N/A	N/A	Ramp inside XWalk2?	N/A
	Road Slope (%)	4.5	N/A	Clear Space?	N/A
	Road X Slope (%)	3.4	N/A	Clear Space to XWalk (in)	N/A
N/A	Any Obstructions?	N/A	N/A	Storm Grate/Utility Hazard?	N/A
	Obstruction Type			Storm Grate/Utility Type	
		N/A			N/A
			Yes	Surface Condition? (G/P)	Good

**Remove & Replace Curb Ramp With Two New Directional Ramps or Equivalent.**

Total Cost: \$ 3200.00
