Access Compliance Report

Public Rights-of-Way

(Curb Ramps)

Intersection ID: 3633	Main Street: COTA_CT	Cross Street: TREYMORE_LN	Location: W
ADA ID: 006FB7B468B4	Ramp Type: Perp	Initial Pass/Fail: Pass	Overall Compliance: No
		Severity Score: 10

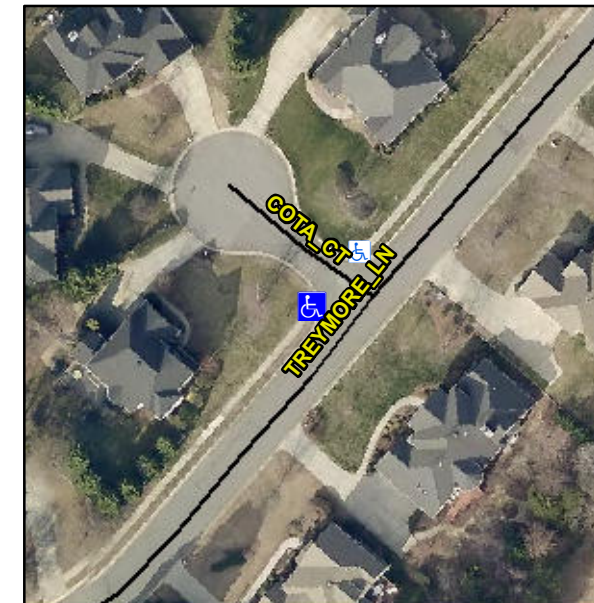
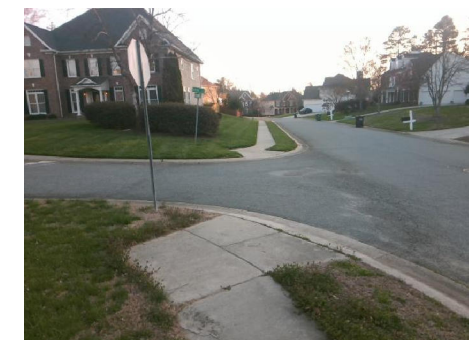
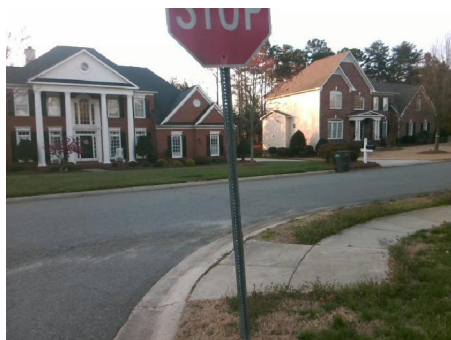
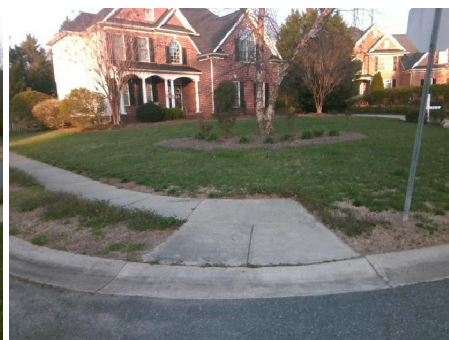
Not Found, R304.2.1, R304.2.2-Perp, R304.3.2-Para, R304.5.3, R305

Compliance	Description	Data	Compliance	Description	Data
N/A	Ramp Length (in)	43.0	Yes	Ramp Slope (%)	7.6
Yes	Ramp Width (in)	48.0	Yes	Ramp XSlope (%)	1.2
N/A	Flare Type LT	Sloped	N/A	Flare Type RT	N/A
N/A	Flare Slope LT (%)	0.9	N/A	Flare Slope RT (%)	3.4
N/A	Flare Traversable LT?	No	N/A	Flare Traversable RT?	No
No	Landing Length (in)	45.0	No	DWS Provided?	No
Yes	Landing Width (in)	81.0	N/A	DWS Contrast?	No
No	Landing Slope (%)	8.1	N/A	DWS Length (in)	N/A
No	Landing X Slope (%)	2.4	N/A	DWS Full Width?	No
N/A	Landing Curb? (Y/N)	No	N/A	DWS Offset (in)	N/A
N/A	Shared Landing?	No			
Yes	Gutter Ponding?	No	Yes	Gutter Slope (%)	0.9
Yes	Gutter Lip Ht (in)	0.0	Yes	Gutter X Slope (%)	1.0
N/A	Painted X Walk1?	No	N/A	Painted X Walk2?	N/A
	X Walk 1 Direction	To NE		X Walk 2 Direction	N/A
N/A	X Walk 1 Width (in)	N/A	N/A	X Walk 2 Width (in)	N/A
	X Walk 1 Slope (%)	4.0		X Walk 2 Slope (%)	N/A
	X Walk 1 X Slope (%)	2.5		X Walk 2 X Slope (%)	N/A

N/A	Ramp inside XWalk1?	N/A	N/A	Ramp inside XWalk2?	N/A
	Road Slope (%)	N/A	N/A	Clear Space?	Yes
	Road X Slope (%)	N/A	N/A	Clear Space to XWalk (in)	N/A
Yes	Any Obstructions?	No	Yes	Storm Grate/Utility Hazard?	No
	Obstruction Type			Storm Grate/Utility Type	
			N/A		N/A
			Yes	Surface Condition? (G/P)	Good

Remove & Replace Entire Ramp.
