# Access Compliance Report

## Public Rights-of-Way

### (Curb Ramps)

| Intersection ID: 45495 | Main Street: COTTON_PRESS_RD | Cross Street: TREE_CANOPY_RD | Location: SE |

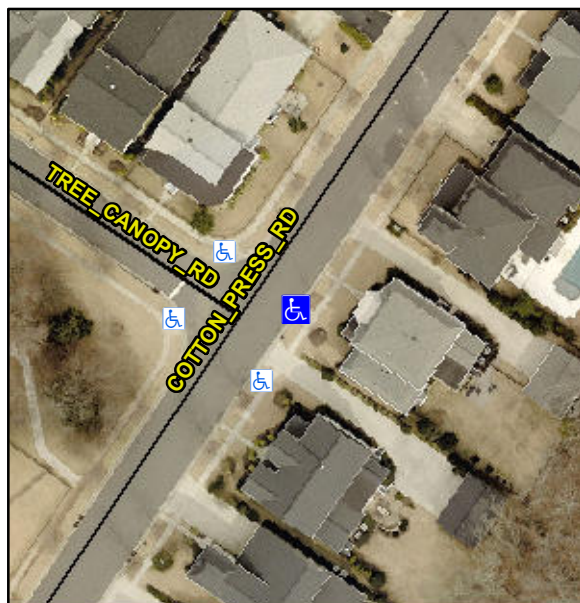
**Not Found, R304.2.2-Perp, R304.3.2-  
Para, R304.5.3, R302.7.2, R304.5.4**

| Compliance | Description | Data | Compliance | Description | Data |
|---|---|---|---|---|---|
| No | Landing Slope (%) | 2.9 | Yes | DWS Length (in) | 24.5 |
| No | Landing X Slope (%) | 2.6 | Yes | DWS Full Width? | Yes |
| Yes | Gutter Ponding? | No | No | Gutter Slope (%) | 12.5 |
| No | Gutter Lip Ht (in) | 0.5 | Yes | Gutter X Slope (%) | 2.0 |

**Remove & Replace Entire Ramp.  
Remove & Replace Gutter.**
