## Access Compliance Report Public Rights-of-Way (Curb Ramps)

Intersection ID: 19528 Main Street: SOUTH\_BV Cross Street: EMERYWOOD\_DR Location: NW

ADA ID: 007D122F3397 Ramp Type: Perp Initial Pass/Fail: Fail Overall Compliance: No Severity Score: 12.5

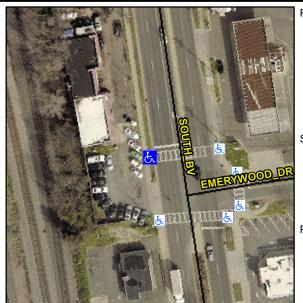
/Possible Solution			Field Measurements/Component Compliance					
Possible Solutions:			Comp	liance Description	Data	Comp	liance Description	Data
Remove & Replace Entire Ramp.		).	N/A	Ramp Length (in)	48.0	No	Ramp Slope (%)	9.4
·	•		Yes	Ramp Width (in)	48.0	Yes	Ramp XSlope (%)	1.8
			N/A	Flare Type LT	N/A	N/A	Flare Type RT	N/A
			N/A	Flare Slope LT (%)	N/A	N/A	Flare Slope RT (%)	N/A
			N/A	Flare Traversable LT?	N/A	N/A	Flare Traversable RT?	N/A
			N/A	Landing Length (in)	N/A	N/A	DWS Provided?	N/A
Surveyor Notes:			N/A	Landing Width (in)	N/A	N/A	DWS Contrast?	N/A
N/A			N/A	Landing Slope (%)	N/A	N/A	DWS Length (in)	N/A
			N/A	Landing X Slope (%)	N/A	N/A	DWS Full Width?	N/A
			N/A	Landing Curb? (Y/N)	N/A	N/A	DWS Offset (in)	N/A
			N/A	Shared Landing?	N/A			
PROW/ADA:			N/A	Gutter Ponding?	N/A	N/A	Gutter Slope (%)	N/A
Not Found, R304.2.2			N/A	Gutter Lip Ht (in)	N/A	N/A	Gutter X Slope (%)	N/A
·			N/A	Painted X Walk1?	Yes	N/A	Painted X Walk2?	N/A

X Walk 1 Direction	To E		X Walk 2 Direction	N/A
			N/A	X Walk 1 Width (in)	112.0	N/A	X Walk 2 Width (in)	N/A
				X Walk 1 Slope (%)	0.5		X Walk 2 Slope (%)	N/A
				X Walk 1 X Slope (%)	0.5		X Walk 2 X Slope (%)	N/A
			N/A	Ramp inside XWalk1?	Yes	N/A	Ramp inside XWalk2?	N/A
				Road Slope (%)	N/A	N/A	Clear Space?	N/A
				Road X Slope (%)	N/A	N/A	Clear Space to XWalk (in)	N/A
			N/A	Any Obstructions?	N/A	N/A	Storm Grate/Utility Hazard?	N/A
Total Cost:	\$	1850.00		Obstruction Type			Storm Grate/Utility Type	
					N/A			N/A
						Yes	Surface Condition? (G/P)	Good
