# Access Compliance Report

## Public Rights-of-Way

| Intersection ID: 47845 | Main Street: DEL_RIO_RD | Cross Street: CACTUS_VALLEY_RD | Location: SW |
| ADA ID: 007F7BF27E38 | Ramp Type: BlendTrans1 | Initial Pass/Fail: Fail | Overall Compliance: No |

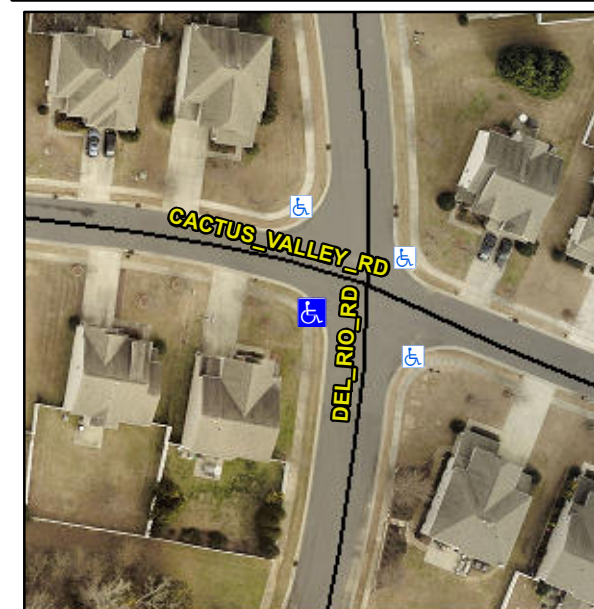
**Not Found, R304.5.1**

| Compliance | Description | Data | Compliance | Description | Data |
|---|---|---|---|---|---|
| No | Ramp Width (in) | 46.5 | Yes | BlendTrans XSlope (%) | 0.8 |

**Remove & Replace Curb Ramp With Two New Directional Ramps or Equivalent.**
