Access Compliance Report

Public Rights-of-Way

(Curb Ramps)

Intersection ID: 5077	Main Street: GRABILL_DR	Cross Street: PASSOUR_RIDGE_LN	Location: NE
ADA ID: 008C98CB11F2	Ramp Type: Perp	Initial Pass/Fail: Fail	Overall Compliance: No
Severity Score: 37.5			
Codes/Mitigation Info/Possible Solution		Field Measurements/Component Compliance

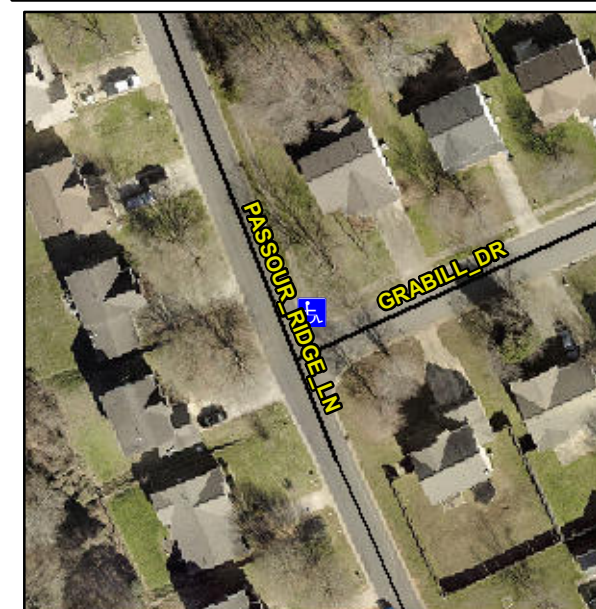
Not Found, R304.2.2, R304.5.3

Compliance	Description	Data	Compliance	Description	Data
N/A	Ramp Length (in)	48.0	No	Ramp Slope (%)	11.7
Yes	Ramp Width (in)	68.0	No	Ramp XSlope (%)	12.9
N/A	Flare Type LT	N/A	N/A	Flare Type RT	N/A
N/A	Flare Slope LT (%)	N/A	N/A	Flare Slope RT (%)	N/A
N/A	Flare Traversable LT?	N/A	N/A	Flare Traversable RT?	N/A
N/A	Landing Length (in)	N/A	N/A	DWS Provided?	N/A
N/A	Landing Width (in)	N/A	N/A	DWS Contrast?	N/A
N/A	Landing Slope (%)	N/A	N/A	DWS Length (in)	N/A
N/A	Landing X Slope (%)	N/A	N/A	DWS Full Width?	N/A
N/A	Landing Curb? (Y/N)	N/A	N/A	DWS Offset (in)	N/A
N/A	Shared Landing?	N/A			
N/A	Gutter Ponding?	N/A	N/A	Gutter Slope (%)	N/A
N/A	Gutter Lip Ht (in)	N/A	N/A	Gutter X Slope (%)	N/A
N/A	Painted X Walk1?	No	N/A	Painted X Walk2?	N/A
	X Walk 1 Direction	To S		X Walk 2 Direction	N/A
N/A	X Walk 1 Width (in)	N/A	N/A	X Walk 2 Width (in)	N/A
	X Walk 1 Slope (%)	1.4		X Walk 2 Slope (%)	N/A
	X Walk 1 X Slope (%)	11.2		X Walk 2 X Slope (%)	N/A

N/A	Ramp inside XWalk1?	N/A	N/A	Ramp inside XWalk2?	N/A
	Road Slope (%)	N/A	N/A	Clear Space?	N/A
	Road X Slope (%)	N/A	N/A	Clear Space to XWalk (in)	N/A
N/A	Any Obstructions?	N/A	N/A	Storm Grate/Utility Hazard?	N/A
	Obstruction Type			Storm Grate/Utility Type	
		N/A			N/A
			Yes	Surface Condition? (G/P)	Good

Remove & Replace Entire Ramp.
