## Access Compliance Report Public Rights-of-Way (Curb Ramps)

Intersection ID: 10709Main Street:MORSON\_STCross Street:PRYOR\_STLocation:NEADA ID: 00ABB29F0241Ramp Type:PerpDiagInitial Pass/Fail:FailOverall Compliance:NoSeverity Score:25

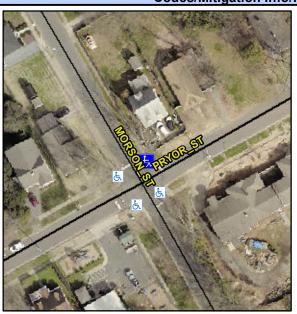
Not Found, R304.2.2, R304.5.3

Field Measure	ments/C	ompoi	nent Compliance	
Compliance Description		Data	Comp	liance Description	Data
N/A	Ramp Length (in)	89.0	No	Ramp Slope (%)	8.4
Yes	Ramp Width (in)	48.0	No	Ramp XSlope (%)	6.5
N/A	Flare Type LT	N/A	N/A	Flare Type RT	N/A
N/A	Flare Slope LT (%)	N/A	N/A	Flare Slope RT (%)	N/A
N/A	Flare Traversable LT?	N/A	N/A	Flare Traversable RT?	N/A
N/A	Landing Length (in)	N/A	N/A	DWS Provided?	N/A
N/A	Landing Width (in)	N/A	N/A	DWS Contrast?	N/A
N/A	Landing Slope (%)	N/A	N/A	DWS Length (in)	N/A
N/A	Landing X Slope (%)	N/A	N/A	DWS Full Width?	N/A
N/A	Landing Curb? (Y/N)	N/A	N/A	DWS Offset (in)	N/A
N/A	Shared Landing?	N/A			
N/A	Gutter Ponding?	N/A	N/A	Gutter Slope (%)	N/A
N/A	Gutter Lip Ht (in)	N/A	N/A	Gutter X Slope (%)	N/A
N/A	Painted X Walk1?	No	N/A	Painted X Walk2?	No
	X Walk 1 Direction	To W		X Walk 2 Direction	To S
N/A	X Walk 1 Width (in)	N/A	N/A	X Walk 2 Width (in)	N/A
	X Walk 1 Slope (%)	2.2		X Walk 2 Slope (%)	2.5

Remove & Replace Curb Ramp With Two New Directional Ramps or Equivalent.
