Access Compliance Report

Public Rights-of-Way

(Curb Ramps)

Intersection ID: 19699	Main Street: CHERRYCREST_LN	Cross Street: ROCKY_RIDGE_DR	Location: NW
ADA ID: 00AC28C6B62B	Ramp Type: PerpDiag	Initial Pass/Fail: Fail	Overall Compliance: No
Severity Score: 13.75			
Codes/Mitigation Info/Possible Solution		Field Measurements/Component Compliance

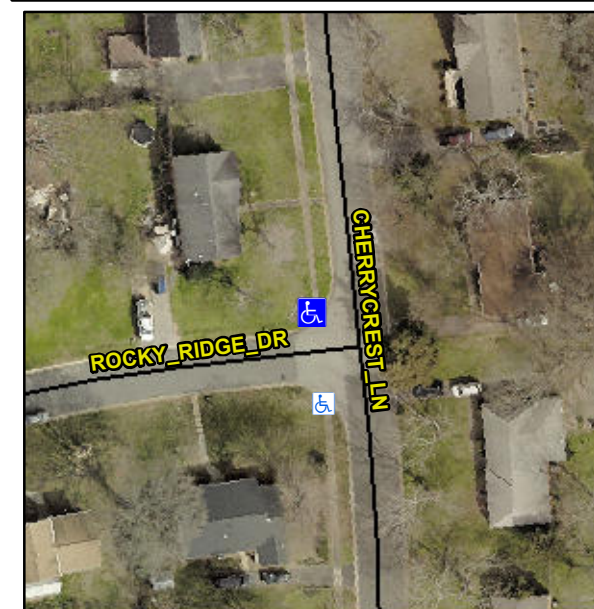
Not Found, R304.2.2, R304.5.3

Compliance	Description	Data	Compliance	Description	Data
N/A	Ramp Length (in)	48.0	No	Ramp Slope (%)	8.5
Yes	Ramp Width (in)	48.0	No	Ramp XSlope (%)	3.3
N/A	Flare Type LT	N/A	N/A	Flare Type RT	N/A
N/A	Flare Slope LT (%)	N/A	N/A	Flare Slope RT (%)	N/A
N/A	Flare Traversable LT?	N/A	N/A	Flare Traversable RT?	N/A
N/A	Landing Length (in)	N/A	N/A	DWS Provided?	N/A
N/A	Landing Width (in)	N/A	N/A	DWS Contrast?	N/A
N/A	Landing Slope (%)	N/A	N/A	DWS Length (in)	N/A
N/A	Landing X Slope (%)	N/A	N/A	DWS Full Width?	N/A
N/A	Landing Curb? (Y/N)	N/A	N/A	DWS Offset (in)	N/A
N/A	Shared Landing?	N/A			
N/A	Gutter Ponding?	N/A	N/A	Gutter Slope (%)	N/A
N/A	Gutter Lip Ht (in)	N/A	N/A	Gutter X Slope (%)	N/A
N/A	Painted X Walk1?	No	N/A	Painted X Walk2?	No
	X Walk 1 Direction	To S		X Walk 2 Direction	To E
N/A	X Walk 1 Width (in)	N/A	N/A	X Walk 2 Width (in)	N/A
	X Walk 1 Slope (%)	2.8		X Walk 2 Slope (%)	5.9
	X Walk 1 X Slope (%)	5.7		X Walk 2 X Slope (%)	0.1

N/A	Ramp inside XWalk1?	N/A	N/A	Ramp inside XWalk2?	N/A
	Road Slope (%)	1.7	N/A	Clear Space?	N/A
	Road X Slope (%)	4.8	N/A	Clear Space to XWalk (in)	N/A
N/A	Any Obstructions?	N/A	N/A	Storm Grate/Utility Hazard?	N/A
	Obstruction Type			Storm Grate/Utility Type	
		N/A			N/A
		Yes		Surface Condition? (G/P)	Good

Remove & Replace Curb Ramp With Two New Directional Ramps or Equivalent.
