# Access Compliance Report

## Public Rights-of-Way

### (Curb Ramps)

| Intersection ID: 5236 | Main Street: COPPALA_DR | Cross Street: KORNIV_DR | Location: | SW |

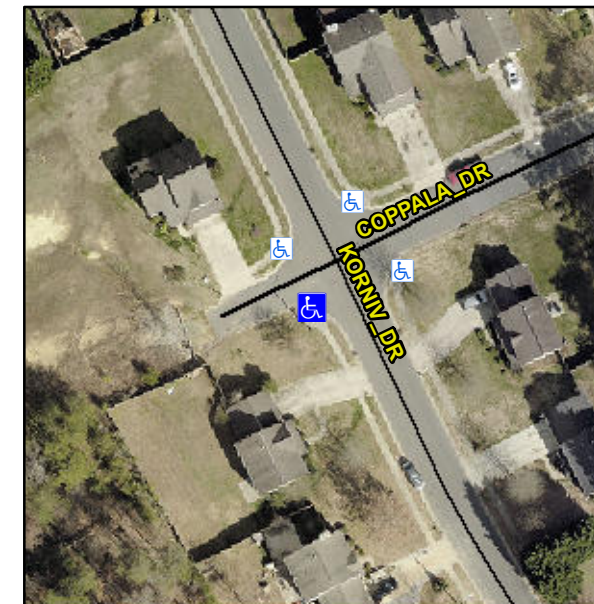
| ADA ID: 00B1469F3DCB | Ramp Type: PerpDiag | Initial Pass/Fail: Fail | Overall Compliance: No | Severity Score: 25 |

| Compliance | Description | Data | Compliance | Description | Data |
|---|---|---|---|---|---|
| N/A | Ramp Length (in) | 47.0 | No | Ramp Slope (%) | 12.5 |

**Remove & Replace Curb Ramp With Two New Directional Ramps or Equivalent.**

**R304.2.2**

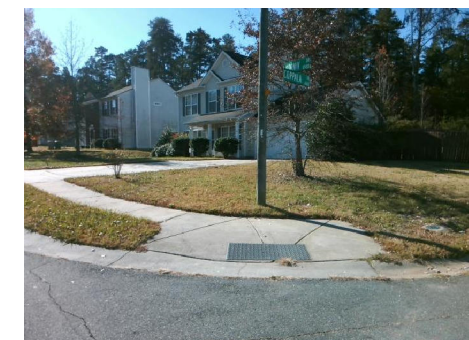
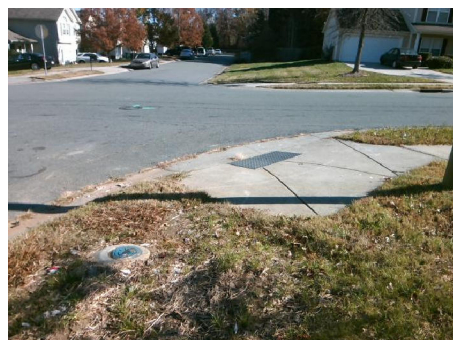
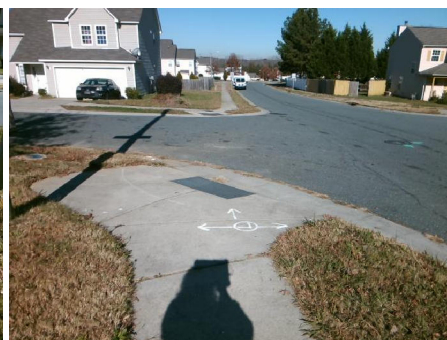
| Compliance | Description | Data | Compliance | Description | Data |
|---|---|---|---|---|---|
| Yes | Ramp Width (in) | 70.0 | Yes | Ramp XSlope (%) | 1.5 |
| | | | Yes | Surface Condition? (G/P) | Good |
