Surface Condition? (G/P)

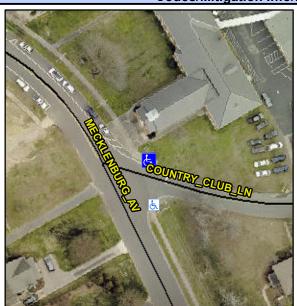
Intersection ID: 11903 Main Street: COUNTRY_CLUB_LN Cross Street: MECKLENBURG_AV Location: E

ADA ID: 00B95434B110 Ramp Type: Perp Initial Pass/Fail: Fail Overall Compliance: No Severity Score: 8.75

Field Measurements/Component Comphance					
Compliance Description		Data	Compliance Description		Data
N/A	Ramp Length (in)	57.0	Yes	Ramp Slope (%)	5.7
No	Ramp Width (in)	47.5	Yes	Ramp XSlope (%)	1.4
N/A	Flare Type LT	N/A	N/A	Flare Type RT	N/A
N/A	Flare Slope LT (%)	N/A	N/A	Flare Slope RT (%)	N/A
N/A	Flare Traversable LT?	N/A	N/A	Flare Traversable RT?	N/A
N/A	Landing Length (in)	N/A	N/A	DWS Provided?	N/A
N/A	Landing Width (in)	N/A	N/A	DWS Contrast?	N/A
N/A	Landing Slope (%)	N/A	N/A	DWS Length (in)	N/A
N/A	Landing X Slope (%)	N/A	N/A	DWS Full Width?	N/A
N/A	Landing Curb? (Y/N)	N/A	N/A	DWS Offset (in)	N/A
N/A	Shared Landing?	N/A			
N/A	Gutter Ponding?	Yes	N/A	Gutter Slope (%)	N/A
N/A	Gutter Lip Ht (in)	N/A	N/A	Gutter X Slope (%)	N/A
N/A	Painted X Walk1?	No	N/A	Painted X Walk2?	N/A
	X Walk 1 Direction	To S		X Walk 2 Direction	N/A
N/A	X Walk 1 Width (in)	N/A	N/A	X Walk 2 Width (in)	N/A
	X Walk 1 Slope (%)	2.6		X Walk 2 Slope (%)	N/A

X Walk 1 X Slope (%)	2.8		X Walk 2 X Slope (%)	N/A
N/A	Ramp inside XWalk1?	N/A	N/A	Ramp inside XWalk2?	N/A
	Road Slope (%)	N/A	N/A	Clear Space?	N/A
	Road X Slope (%)	N/A	N/A	Clear Space to XWalk (in)	N/A
N/A	Any Obstructions?	N/A	N/A	Storm Grate/Utility Hazard?	N/A
	Obstruction Type			Storm Grate/Utility Type

Possible Solutions:

Remove & Replace Entire Ramp.

R304.5.1
