# Access Compliance Report

## Public Rights-of-Way

### (Curb Ramps)

| Intersection ID: N/A | Main Street: COSTIGAN_LN | Cross Street: BALLANTYNE_VILLAGE_WY | Location: SW |

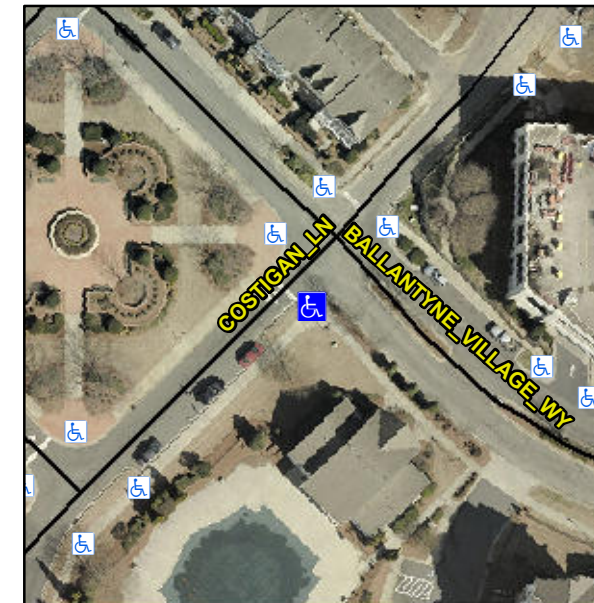
| ADA ID: 00BB720A407E | Ramp Type: PerpDiag | Initial Pass/Fail: Fail | Overall Compliance: No |

**R304.2.2**

| Compliance | Description | Data | Compliance | Description | Data |
|---|---|---|---|---|---|
| N/A | Ramp Length (in) | 86.0 | No | Ramp Slope (%) | 9.6 |

**Remove & Replace Curb Ramp With Two New Directional Ramps or Equivalent.**
