# Access Compliance Report

## Public Rights-of-Way

### (Curb Ramps)

| Intersection ID: 29131 | Main Street: ALDERPOINT_LN | Cross Street: ANGWIN_PL | Location: SE |

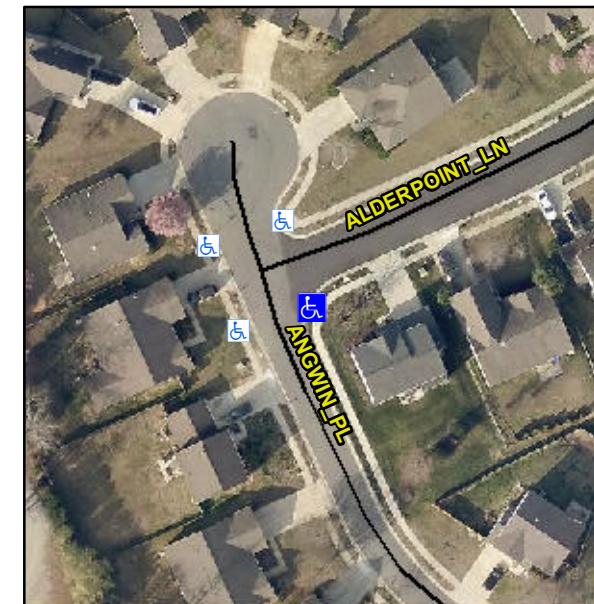
| ADA ID: 00BBF01AE58D | Ramp Type: BlendTrans1 | Initial Pass/Fail: Pass | Overall Compliance: No |
| Severity Score: 25.25 | | | |

| Compliance | Description | Data | Compliance | Description | Data |
|---|---|---|---|---|---|
| Yes | Ramp Width (in) | 119.0 | No | BlendTrans XSlope (%) | 3.3 |
| No | Landing X Slope (%) | 4.3 | N/A | DWS Full Width? | No |
| No | Gutter Lip Ht (in) | 1.0 | No | Gutter X Slope (%) | 4.7 |

**Remove & Replace Curb Ramp With Two New Directional Ramps or Equivalent. Remove & Replace Gutter.**

**R304.5.3, R305, R302.7.2**
