Intersection ID: N/A	Main Street: CRESSWIND BV	Cross Street: SILVER SPRINGS CT	Location:	N
ADA ID: 00C2F88D65EF	Ramp Type: Perp	Initial Pass/Fail: Fail	Overall Compliance: No	Severity Score: 13.75

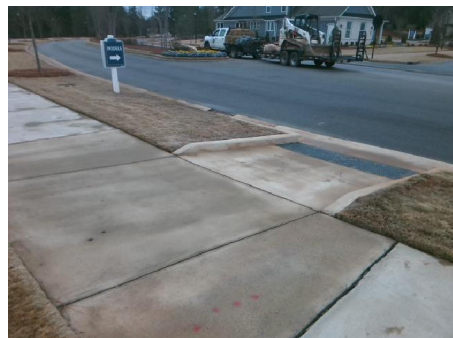
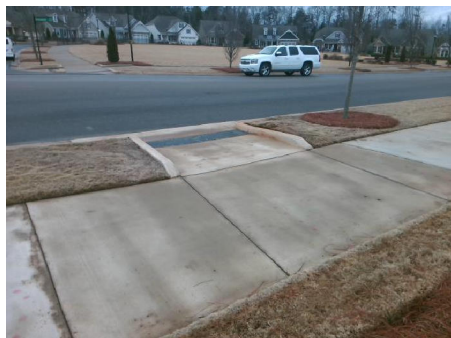
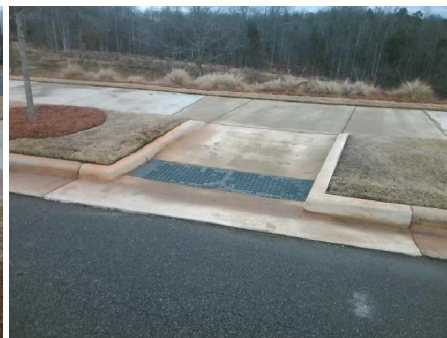
Compliance	Description	Data	Compliance	Description	Data
N/A	Ramp Length (in)	97.0	No	Ramp Slope (%)	9.0
Yes	Ramp Width (in)	89.0	No	Ramp XSlope (%)	2.2
N/A	Flare Type LT	N/A	N/A	Flare Type RT	N/A
N/A	Flare Slope LT (%)	N/A	N/A	Flare Slope RT (%)	N/A
N/A	Flare Traversable LT?	No	N/A	Flare Traversable RT?	No
N/A	Landing Length (in)	N/A	N/A	DWS Provided?	N/A
N/A	Landing Width (in)	N/A	N/A	DWS Contrast?	N/A
N/A	Landing Slope (%)	N/A	N/A	DWS Length (in)	N/A
N/A	Landing X Slope (%)	N/A	N/A	DWS Full Width?	N/A
N/A	Landing Curb? (Y/N)	N/A	N/A	DWS Offset (in)	N/A
N/A	Shared Landing?	N/A			
N/A	Gutter Ponding?	N/A	N/A	Gutter Slope (%)	N/A
N/A	Gutter Lip Ht (in)	N/A	N/A	Gutter X Slope (%)	N/A
N/A	Painted X Walk1?	No	N/A	Painted X Walk2?	N/A
	X Walk 1 Direction	To SW		X Walk 2 Direction	N/A
N/A	X Walk 1 Width (in)	N/A	N/A	X Walk 2 Width (in)	N/A
	X Walk 1 Slope (%)	4.8		X Walk 2 Slope (%)	N/A
	X Walk 1 X Slope (%)	0.6		X Walk 2 X Slope (%)	N/A

N/A	Ramp inside XWalk1?	N/A	N/A	Ramp inside XWalk2?	N/A
	Road Slope (%)	N/A	N/A	Clear Space?	N/A
	Road X Slope (%)	N/A	N/A	Clear Space to XWalk (in)	N/A
N/A	Any Obstructions?	N/A	N/A	Storm Grate/Utility Hazard?	N/A
	Obstruction Type			Storm Grate/Utility Type	
		N/A			N/A
			Yes	Surface Condition? (G/P)	Good

Remove & Replace Entire Ramp.

R304.2.2, R304.5.3

Total Cost: \$ 1850.00
