# Access Compliance Report

## Public Rights-of-Way

| Intersection ID: 46343 | Main Street: MEADOW_KNOLL_DR | Cross Street: STREAM_BANK_DR | Location: | SW |
| ADA ID: 00C34773EAE8 | Ramp Type: Perp | Initial Pass/Fail: Fail | Overall Compliance: No | Severity Score: 25 |

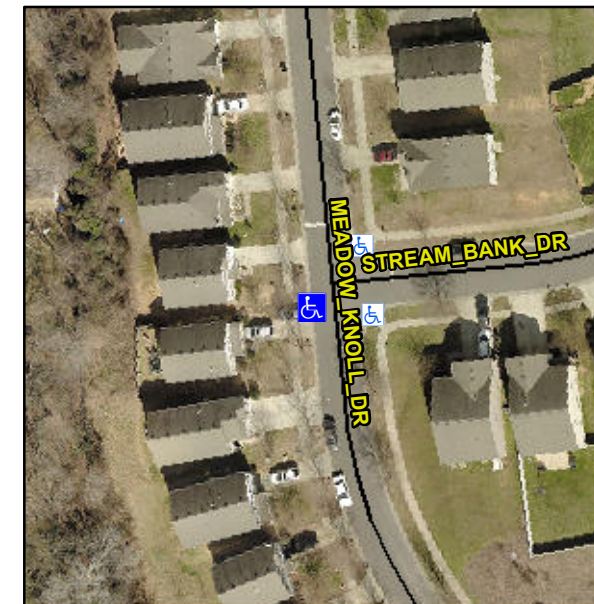
**Not Found, R304.2.2, R304.5.3**

| Compliance | Description | Data | Compliance | Description | Data |
|---|---|---|---|---|---|
| N/A | Ramp Length (in) | 84.0 | No | Ramp Slope (%) | 9.9 |
| Yes | Ramp Width (in) | 48.0 | No | Ramp XSlope (%) | 6.5 |

**Remove & Replace Entire Ramp.**

Total Cost: \$ 1850.00
