# Access Compliance Report

## Public Rights-of-Way

### (Curb Ramps)

Intersection ID: 17126	Main Street: MISSION_HILLS_RD	Cross Street: TEABERRY_CT	Location: NE
ADA ID: 00D0BE5CDB92	Ramp Type: PerpDiag	Initial Pass/Fail: Fail	Overall Compliance: No
			Severity Score: 13.75

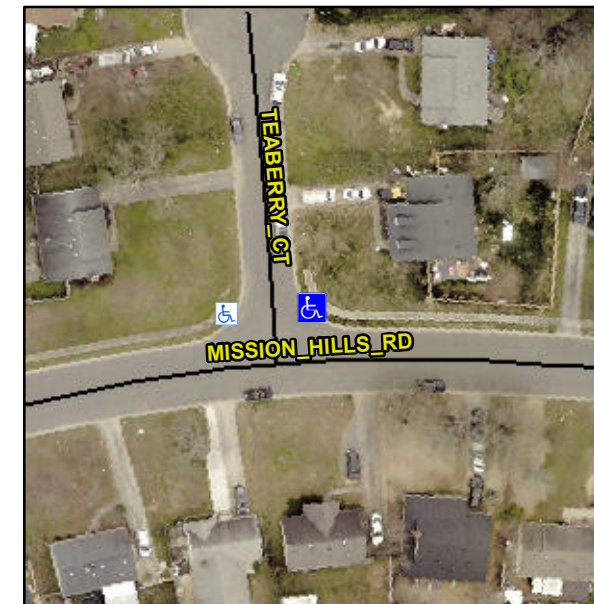
**Not Found, R304.2.2, R304.5.3**

Compliance	Description	Data	Compliance	Description	Data
N/A	Ramp Length (in)	46.0	No	Ramp Slope (%)	9.1
Yes	Ramp Width (in)	48.0	No	Ramp XSlope (%)	2.1
N/A	Flare Type LT	N/A	N/A	Flare Type RT	N/A
N/A	Flare Slope LT (%)	N/A	N/A	Flare Slope RT (%)	N/A
N/A	Flare Traversable LT?	N/A	N/A	Flare Traversable RT?	N/A
N/A	Landing Length (in)	N/A	N/A	DWS Provided?	N/A
N/A	Landing Width (in)	N/A	N/A	DWS Contrast?	N/A
N/A	Landing Slope (%)	N/A	N/A	DWS Length (in)	N/A
N/A	Landing X Slope (%)	N/A	N/A	DWS Full Width?	N/A
N/A	Landing Curb? (Y/N)	N/A	N/A	DWS Offset (in)	N/A
N/A	Shared Landing?	N/A			
N/A	Gutter Ponding?	N/A	N/A	Gutter Slope (%)	N/A
N/A	Gutter Lip Ht (in)	N/A	N/A	Gutter X Slope (%)	N/A
N/A	Painted X Walk1?	No	N/A	Painted X Walk2?	No
	X Walk 1 Direction	To NW		X Walk 2 Direction	To SW
N/A	X Walk 1 Width (in)	N/A	N/A	X Walk 2 Width (in)	N/A
	X Walk 1 Slope (%)	3.6		X Walk 2 Slope (%)	0.0
	X Walk 1 X Slope (%)	0.6		X Walk 2 X Slope (%)	4.2

N/A	Ramp inside XWalk1?	N/A	N/A	Ramp inside XWalk2?	N/A
	Road Slope (%)	3.9	N/A	Clear Space?	N/A
	Road X Slope (%)	3.1	N/A	Clear Space to XWalk (in)	N/A
N/A	Any Obstructions?	N/A	N/A	Storm Grate/Utility Hazard?	N/A
	Obstruction Type			Storm Grate/Utility Type	
		N/A			N/A
			Yes	Surface Condition? (G/P)	Good

**Remove & Replace Curb Ramp With Two New Directional Ramps or Equivalent.**
