# Access Compliance Report

## Public Rights-of-Way

### (Curb Ramps)

Intersection ID: 13891	Main Street: CLEMENT_AV	Cross Street: E_7TH_ST	Location: E
ADA ID: 00D17612E320	Ramp Type: PerpDiag	Initial Pass/Fail: Fail	Overall Compliance: No
Severity Score: 12.5			
Codes/Mitigation Info/Possible Solution		Field Measurements/Component Compliance

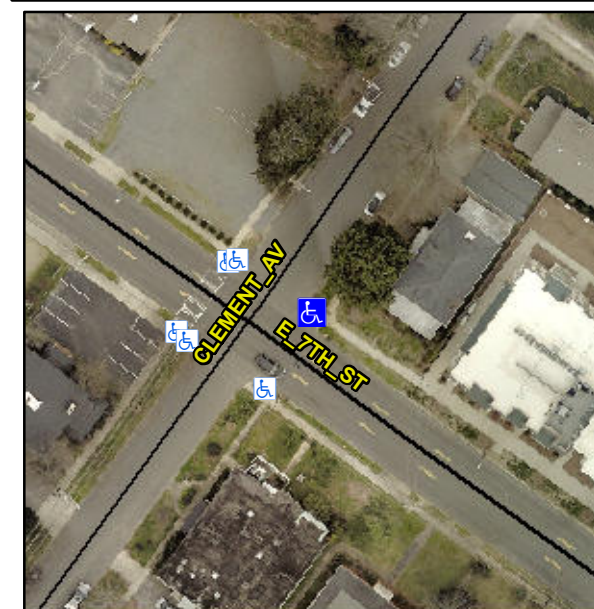
Compliance	Description	Data	Compliance	Description	Data
N/A	Ramp Length (in)	75.0	No	Ramp Slope (%)	9.8
Yes	Ramp Width (in)	60.0	Yes	Ramp XSlope (%)	0.4
N/A	Flare Type LT	N/A	N/A	Flare Type RT	N/A
N/A	Flare Slope LT (%)	N/A	N/A	Flare Slope RT (%)	N/A
N/A	Flare Traversable LT?	N/A	N/A	Flare Traversable RT?	N/A
N/A	Landing Length (in)	N/A	N/A	DWS Provided?	N/A
N/A	Landing Width (in)	N/A	N/A	DWS Contrast?	N/A
N/A	Landing Slope (%)	N/A	N/A	DWS Length (in)	N/A
N/A	Landing X Slope (%)	N/A	N/A	DWS Full Width?	N/A
N/A	Landing Curb? (Y/N)	N/A	N/A	DWS Offset (in)	N/A
N/A	Shared Landing?	N/A			
N/A	Gutter Ponding?	N/A	N/A	Gutter Slope (%)	N/A
N/A	Gutter Lip Ht (in)	N/A	N/A	Gutter X Slope (%)	N/A
N/A	Painted X Walk1?	No	N/A	Painted X Walk2?	No
	X Walk 1 Direction	To NW		X Walk 2 Direction	To SW
N/A	X Walk 1 Width (in)	N/A	N/A	X Walk 2 Width (in)	N/A
	X Walk 1 Slope (%)	0.4		X Walk 2 Slope (%)	1.3
	X Walk 1 X Slope (%)	1.4		X Walk 2 X Slope (%)	1.5

N/A	Ramp inside XWalk1?	N/A	N/A	Ramp inside XWalk2?	N/A
	Road Slope (%)	0.2	N/A	Clear Space?	N/A
	Road X Slope (%)	1.0	N/A	Clear Space to XWalk (in)	N/A
N/A	Any Obstructions?	N/A	N/A	Storm Grate/Utility Hazard?	N/A
	Obstruction Type			Storm Grate/Utility Type	
		N/A			N/A
		Yes		Surface Condition? (G/P)	Good

**Remove & Replace Curb Ramp With Two New Directional Ramps or Equivalent.**
