# Access Compliance Report

## Public Rights-of-Way

### (Curb Ramps)

Intersection ID: 10308	Main Street: BRICE_ST	Cross Street: RUSH_AV	Location: NE
ADA ID: 00DDCC53FF1B	Ramp Type: BlendTrans2	Initial Pass/Fail: Fail	Overall Compliance: No
			Severity Score: 21.25

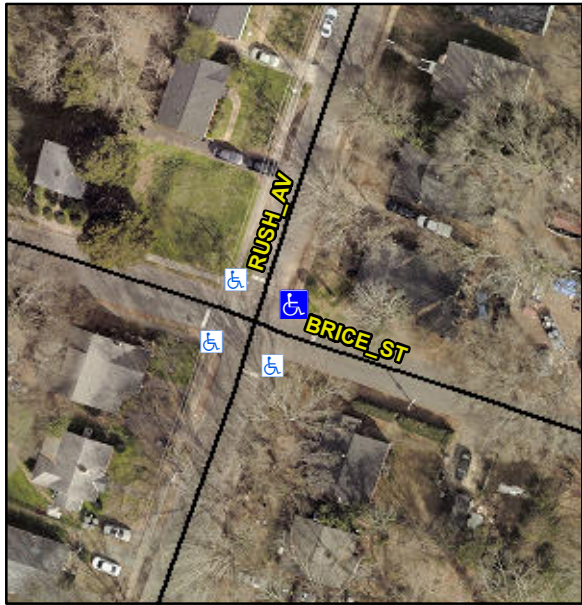
Possible Solutions:		Compliance	Description	Data	Compliance	Description	Data
	<b>Remove &amp; Replace Curb Ramp With Two New Directional Ramps or Equivalent.</b>		N/A	Ramp Length (in)	71.0	Yes	BlendTrans Slope (%)	1.5
			No	Ramp Width (in)	45.0	No	BlendTrans XSlope (%)	5.5
			N/A	Flare Type LT	N/A	N/A	Flare Type RT	N/A
			N/A	Flare Slope LT (%)	N/A	N/A	Flare Slope RT (%)	N/A
			N/A	Flare Traversable LT?	N/A	N/A	Flare Traversable RT?	N/A
	Surveyor Notes:		N/A	Landing Length (in)	N/A	N/A	DWS Provided?	N/A
			N/A	Landing Width (in)	N/A	N/A	DWS Contrast?	N/A
			N/A	Landing Slope (%)	N/A	N/A	DWS Length (in)	N/A
			N/A	Landing X Slope (%)	N/A	N/A	DWS Full Width?	N/A
N/A			Landing Curb? (Y/N)	N/A	N/A	DWS Offset (in)	N/A	
PROW/ADA:		N/A	Shared Landing?	N/A				
<b>R304.5.1, R304.5.3</b>		N/A	Gutter Ponding?	N/A	N/A	Gutter Slope (%)	N/A

N/A	Gutter Lip Ht (in)	N/A	N/A	Gutter X Slope (%)	N/A	
		N/A	Painted X Walk1?	No	N/A	Painted X Walk2?	N/A	
			X Walk 1 Direction	To SW		X Walk 2 Direction	N/A	
			X Walk 1 Width (in)	N/A		X Walk 2 Width (in)	N/A	
			X Walk 1 Slope (%)	2.5		X Walk 2 Slope (%)	N/A	
			X Walk 1 X Slope (%)	4.8		X Walk 2 X Slope (%)	N/A	
		N/A	Ramp inside XWalk1?	N/A	N/A	Ramp inside XWalk2?	N/A	
			Road Slope (%)	4.8		Clear Space?	N/A	
			Road X Slope (%)	2.5	N/A	Clear Space to XWalk (in)	N/A	
		N/A	Any Obstructions?	N/A	N/A	Storm Grate/Utility Hazard?	N/A	
			Obstruction Type			Storm Grate/Utility Type		
					N/A		N/A	
					Yes	Surface Condition? (G/P)	Good	
					N/A	Curb Slope (%)	1.9
