# Access Compliance Report

## Public Rights-of-Way

### (Curb Ramps)

Intersection ID: 29700	Main Street: CAMERON_CREEK_DR	Cross Street: WEDDINGTON_RIDGE_LN	Location:	N
ADA ID: 00E2D8C5206E	Ramp Type: PerpDiag	Initial Pass/Fail: Fail	Overall Compliance: No	Severity Score: 17.5

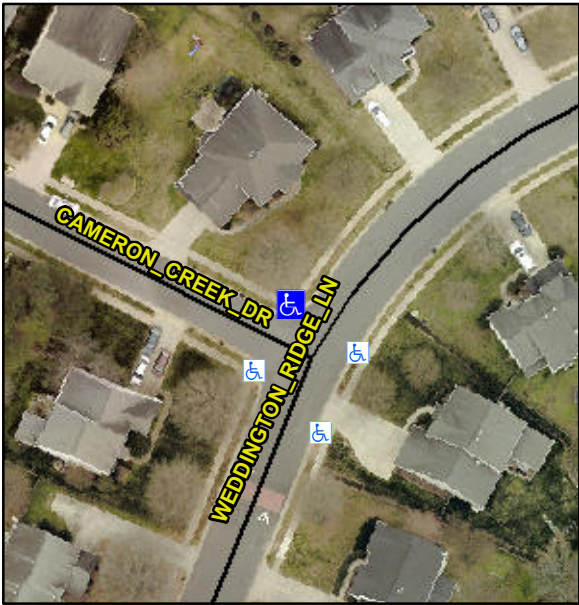
<b>N/A</b>	Flare Traversable LT?	<b>N/A</b>	<b>N/A</b>	Flare Traversable RT?	<b>N/A</b>
			<b>N/A</b>	Landing Length (in)	<b>N/A</b>	<b>N/A</b>	DWS Provided?	<b>N/A</b>
			<b>N/A</b>	Landing Width (in)	<b>N/A</b>	<b>N/A</b>	DWS Contrast?	<b>N/A</b>
			<b>N/A</b>	Landing Slope (%)	<b>N/A</b>	<b>N/A</b>	DWS Length (in)	<b>N/A</b>
			<b>N/A</b>	Landing X Slope (%)	<b>N/A</b>	<b>N/A</b>	DWS Full Width?	<b>N/A</b>
			<b>N/A</b>	Landing Curb? (Y/N)	<b>N/A</b>	<b>N/A</b>	DWS Offset (in)	<b>N/A</b>
			<b>N/A</b>	Shared Landing?	<b>N/A</b>			
			<b>N/A</b>	Gutter Ponding?	<b>N/A</b>	<b>N/A</b>	Gutter Slope (%)	<b>N/A</b>
			<b>N/A</b>	Gutter Lip Ht (in)	<b>N/A</b>	<b>N/A</b>	Gutter X Slope (%)	<b>N/A</b>
			<b>N/A</b>	Painted X Walk1?	<b>No</b>	<b>N/A</b>	Painted X Walk2?	<b>No</b>
				X Walk 1 Direction	<b>To SW</b>		X Walk 2 Direction	<b>To SE</b>
			<b>N/A</b>	X Walk 1 Width (in)	<b>N/A</b>	<b>N/A</b>	X Walk 2 Width (in)	<b>N/A</b>

X Walk 1 Slope (%)	<b>0.7</b>		X Walk 2 Slope (%)	<b>0.2</b>
				X Walk 1 X Slope (%)	<b>0.4</b>		X Walk 2 X Slope (%)	<b>1.0</b>
			<b>N/A</b>	Ramp inside XWalk1?	<b>N/A</b>	<b>N/A</b>	Ramp inside XWalk2?	<b>N/A</b>
				Road Slope (%)	<b>1.5</b>	<b>N/A</b>	Clear Space?	<b>N/A</b>
				Road X Slope (%)	<b>4.8</b>	<b>N/A</b>	Clear Space to XWalk (in)	<b>N/A</b>
			<b>N/A</b>	Any Obstructions?	<b>N/A</b>	<b>N/A</b>	Storm Grate/Utility Hazard?	<b>N/A</b>
				Obstruction Type			Storm Grate/Utility Type	
					<b>N/A</b>			<b>N/A</b>
						<b>Yes</b>	Surface Condition? (G/P)	<b>Good</b>

Possible Solutions:		<b>Remove &amp; Replace Curb Ramp With Two New Directional Ramps or Equivalent.</b>					
	Surveyor Notes:		<b>N/A</b>					
	PROW/ADA:		<b>Not Found, R304.5.1</b>					
	Street 1 Name		<b>CAMERON CREEK DR</b>					
	Stop Condition-Street 2		<b>StopSign</b>					
	Street 2 Name		<b>WEDDINGTON RIDGE LN</b>					
	Stop Condition-Street 1		<b>None</b>					
	Total Cost:		<b>\$ 3200.00</b>					
			<b>Compliance</b>	<b>Description</b>	<b>Data</b>	<b>Compliance</b>	<b>Description</b>	<b>Data</b>
			<b>N/A</b>	Ramp Length (in)	<b>54.0</b>	<b>Yes</b>	Ramp Slope (%)	<b>5.3</b>
			<b>No</b>	Ramp Width (in)	<b>35.0</b>	<b>Yes</b>	Ramp XSlope (%)	<b>1.5</b>
			<b>N/A</b>	Flare Type LT	<b>N/A</b>	<b>N/A</b>	Flare Type RT	<b>N/A</b>
			<b>N/A</b>	Flare Slope LT (%)	<b>N/A</b>	<b>N/A</b>	Flare Slope RT (%)	<b>N/A</b>
