Access Compliance Report

Public Rights-of-Way

(Curb Ramps)

Intersection ID: 14235	Main Street: CAMDEN_RD	Cross Street: E_TREMONT_AV	Location: SW
ADA ID: 00F55ECA0F0E	Ramp Type: Perp	Initial Pass/Fail: Fail	Overall Compliance: No
			Severity Score: 21.25

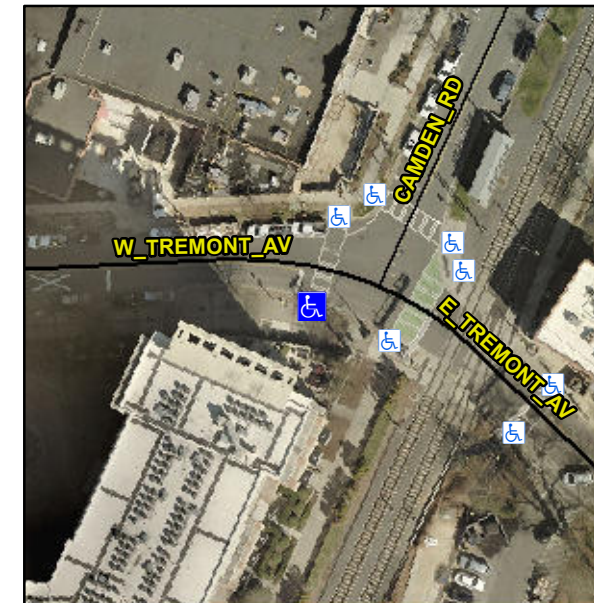
Compliance	Description	Data	Compliance	Description	Data
N/A	Ramp Length (in)	71.0	No	Ramp Slope (%)	8.6
No	Ramp Width (in)	47.0	Yes	Ramp XSlope (%)	1.7
N/A	Flare Type LT	N/A	N/A	Flare Type RT	N/A
N/A	Flare Slope LT (%)	N/A	N/A	Flare Slope RT (%)	N/A
N/A	Flare Traversable LT?	N/A	N/A	Flare Traversable RT?	N/A
N/A	Landing Length (in)	N/A	N/A	DWS Provided?	N/A
N/A	Landing Width (in)	N/A	N/A	DWS Contrast?	N/A
N/A	Landing Slope (%)	N/A	N/A	DWS Length (in)	N/A
N/A	Landing X Slope (%)	N/A	N/A	DWS Full Width?	N/A
N/A	Landing Curb? (Y/N)	N/A	N/A	DWS Offset (in)	N/A
N/A	Shared Landing?	N/A			
N/A	Gutter Ponding?	N/A	N/A	Gutter Slope (%)	N/A
N/A	Gutter Lip Ht (in)	N/A	N/A	Gutter X Slope (%)	N/A
N/A	Painted X Walk1?	Yes	N/A	Painted X Walk2?	N/A
	X Walk 1 Direction	To NE		X Walk 2 Direction	N/A
N/A	X Walk 1 Width (in)	102.0	N/A	X Walk 2 Width (in)	N/A
	X Walk 1 Slope (%)	1.2		X Walk 2 Slope (%)	N/A
	X Walk 1 X Slope (%)	1.6		X Walk 2 X Slope (%)	N/A

N/A	Ramp inside XWalk1?	Yes	N/A	Ramp inside XWalk2?	N/A
	Road Slope (%)	N/A	N/A	Clear Space?	N/A
	Road X Slope (%)	N/A	N/A	Clear Space to XWalk (in)	N/A
N/A	Any Obstructions?	N/A	N/A	Storm Grate/Utility Hazard?	N/A
	Obstruction Type			Storm Grate/Utility Type	
			N/A		N/A
			Yes	Surface Condition? (G/P)	Good

Possible Solutions:

Remove & Replace Entire Ramp.

R304.5.1, R304.2.2
