Access Compliance Report

Public Rights-of-Way

(Curb Ramps)

Intersection ID: 13611	Main Street: E_MOREHEAD_ST	Cross Street: EUCLID_AV	Location: NE
ADA ID: 00FF3BAFB896	Ramp Type: PerpDiag	Initial Pass/Fail: Fail	Overall Compliance: No
Severity Score: 12.5			
Codes/Mitigation Info/Possible Solution		Field Measurements/Component Compliance

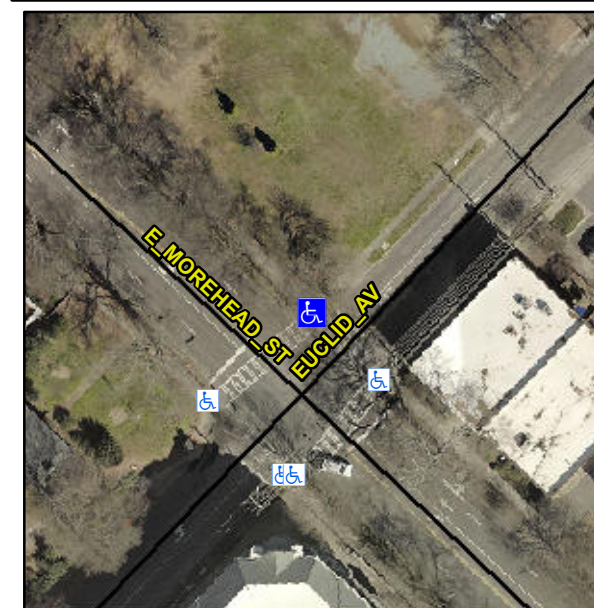
Compliance	Description	Data	Compliance	Description	Data
N/A	Ramp Length (in)	78.0	No	Ramp Slope (%)	11.4
Yes	Ramp Width (in)	48.0	Yes	Ramp XSlope (%)	0.3
N/A	Flare Type LT	N/A	N/A	Flare Type RT	N/A
N/A	Flare Slope LT (%)	N/A	N/A	Flare Slope RT (%)	N/A
N/A	Flare Traversable LT?	N/A	N/A	Flare Traversable RT?	N/A
N/A	Landing Length (in)	N/A	N/A	DWS Provided?	N/A
N/A	Landing Width (in)	N/A	N/A	DWS Contrast?	N/A
N/A	Landing Slope (%)	N/A	N/A	DWS Length (in)	N/A
N/A	Landing X Slope (%)	N/A	N/A	DWS Full Width?	N/A
N/A	Landing Curb? (Y/N)	N/A	N/A	DWS Offset (in)	N/A
N/A	Shared Landing?	N/A			
N/A	Gutter Ponding?	N/A	N/A	Gutter Slope (%)	N/A
N/A	Gutter Lip Ht (in)	N/A	N/A	Gutter X Slope (%)	N/A
N/A	Painted X Walk1?	Yes	N/A	Painted X Walk2?	Yes
	X Walk 1 Direction	To SW		X Walk 2 Direction	To SE
N/A	X Walk 1 Width (in)	112.0	N/A	X Walk 2 Width (in)	110.0
	X Walk 1 Slope (%)	5.0		X Walk 2 Slope (%)	2.4
	X Walk 1 X Slope (%)	2.1		X Walk 2 X Slope (%)	4.8

N/A	Ramp inside XWalk1?	Yes	N/A	Ramp inside XWalk2?	Yes
	Road Slope (%)	3.3	N/A	Clear Space?	N/A
	Road X Slope (%)	4.5	N/A	Clear Space to XWalk (in)	N/A
N/A	Any Obstructions?	N/A	N/A	Storm Grate/Utility Hazard?	N/A
	Obstruction Type			Storm Grate/Utility Type	
		N/A			N/A
		Yes		Surface Condition? (G/P)	Good

Possible Solutions:

Remove & Replace Curb Ramp With Two New Directional Ramps or Equivalent.
