## Access Compliance Report Public Rights-of-Way (Curb Ramps)

Intersection ID: 50595Main Street:BENDING\_BRANCH\_RDCross Street:GRAY\_WILLOW\_RDLocation:WADA ID: 00FFB4A52903Ramp Type:PerpInitial Pass/Fail:FailOverall Compliance:NoSeverity Score:21.25

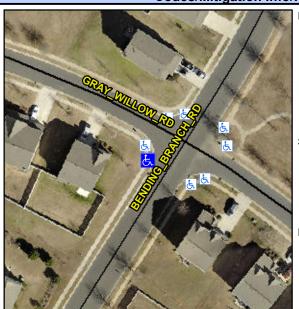
Not Found, R304.5.1, R304.2.2

Field Measurements/Component Compliance					
Compliance Description		Data	Compl	iance Description	Data
N/A	Ramp Length (in)	47.0	No	Ramp Slope (%)	8.4
No	Ramp Width (in)	47.5	Yes	Ramp XSlope (%)	0.1
N/A	Flare Type LT	N/A	N/A	Flare Type RT	N/A
N/A	Flare Slope LT (%)	N/A	N/A	Flare Slope RT (%)	N/A
N/A	Flare Traversable LT?	N/A	N/A	Flare Traversable RT?	N/A
N/A	Landing Length (in)	N/A	N/A	DWS Provided?	N/A
N/A	Landing Width (in)	N/A	N/A	DWS Contrast?	N/A
N/A	Landing Slope (%)	N/A	N/A	DWS Length (in)	N/A
N/A	Landing X Slope (%)	N/A	N/A	DWS Full Width?	N/A
N/A	Landing Curb? (Y/N)	N/A	N/A	DWS Offset (in)	N/A
N/A	Shared Landing?	N/A			
N/A	Gutter Ponding?	N/A	N/A	Gutter Slope (%)	N/A
N/A	Gutter Lip Ht (in)	N/A	N/A	Gutter X Slope (%)	N/A
N/A	Painted X Walk1?	No	N/A	Painted X Walk2?	N/A
	X Walk 1 Direction	To SE		X Walk 2 Direction	N/A
N/A	X Walk 1 Width (in)	N/A	N/A	X Walk 2 Width (in)	N/A
	X Walk 1 Slope (%)	1.8		X Walk 2 Slope (%)	N/A

X Walk 1 X Slope (%)	1.4		X Walk 2 X Slope (%)	N/A
N/A	Ramp inside XWalk1?	N/A	N/A	Ramp inside XWalk2?	N/A
	Road Slope (%)	N/A	N/A	Clear Space?	N/A
	Road X Slope (%)	N/A	N/A	Clear Space to XWalk (in)	N/A
N/A	Any Obstructions?	N/A	N/A	Storm Grate/Utility Hazard?	N/A
	Obstruction Type			Storm Grate/Utility Type	
		N/A			N/A
			Yes	Surface Condition? (G/P)	Good

Remove & Replace Entire Ramp.
