Access Compliance Report Public Rights-of-Way (Curb Ramps)

Intersection ID: N/A Main Street: COUNTRY WALK DR **Cross Street: PINE HOLLOW DR** Location: SW ADA ID: 01181AD2D459 Ramp Type: PerpDiag Initial Pass/Fail: Fail **Overall Compliance: No Severity Score:** 10

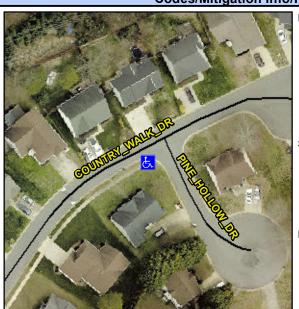
Field Measurements/Component Compliance					
Compliance Description		Data	Compliance Description		Data	
N/A	Ramp Length (in)	49.0	Yes	Ramp Slope (%)	7.1	
No	Ramp Width (in)	41.0	No	Ramp XSlope (%)	3.7	
N/A	Flare Type LT	N/A	N/A	Flare Type RT	N/A	
N/A	Flare Slope LT (%)	N/A	N/A	Flare Slope RT (%)	N/A	
N/A	Flare Traversable LT?	N/A	N/A	Flare Traversable RT?	N/A	
N/A	Landing Length (in)	N/A	N/A	DWS Provided?	N/A	
N/A	Landing Width (in)	N/A	N/A	DWS Contrast?	N/A	
N/A	Landing Slope (%)	N/A	N/A	DWS Length (in)	N/A	
N/A	Landing X Slope (%)	N/A	N/A	DWS Full Width?	N/A	
N/A	Landing Curb? (Y/N)	N/A	N/A	DWS Offset (in)	N/A	
N/A	Shared Landing?	N/A				
N/A	Gutter Ponding?	N/A	N/A	Gutter Slope (%)	N/A	
N/A	Gutter Lip Ht (in)	N/A	N/A	Gutter X Slope (%)	N/A	
N/A	Painted X Walk1?	No	N/A	Painted X Walk2?	No	
	X Walk 1 Direction	To E		X Walk 2 Direction	To N	
N/A	X Walk 1 Width (in)	N/A	N/A	X Walk 2 Width (in)	N/A	
	X Walk 1 Slope (%)	3.7		X Walk 2 Slope (%)	1.0

X Walk 1 X Slope (%)	1.3		X Walk 2 X Slope (%)	0.9	
N/A	Ramp inside XWalk1?	N/A	N/A	Ramp inside XWalk2?	N/A	
	Road Slope (%)	1.6	N/A	Clear Space?	N/A	
	Road X Slope (%)	1.3	N/A	Clear Space to XWalk (in)	N/A	
N/A	Any Obstructions?	N/A	N/A	Storm Grate/Utility Hazard?	N/A	
	Obstruction Type			Storm Grate/Utility Type		
		N/A			N/A	
			Yes	Surface Condition? (G/P)	Good

Possible Solutions: Remove & Replace Curb Ramp With Two New Directional Ramps or Equivalent. Surveyor Notes: N/A PROW/ADA: Not Found, R304.5.1, R304.5.3
