Access Compliance Report

Public Rights-of-Way

(Curb Ramps)

Intersection ID: 52583	Main Street: NEW RENAISSANCE_WY	Cross Street: N/A	Location: NW
ADA ID: 011AC7869962	Ramp Type: Directional1	Initial Pass/Fail: Fail	Overall Compliance: No
Severity Score: 1.25			
Codes/Mitigation Info/Possible Solution		Field Measurements/Component Compliance

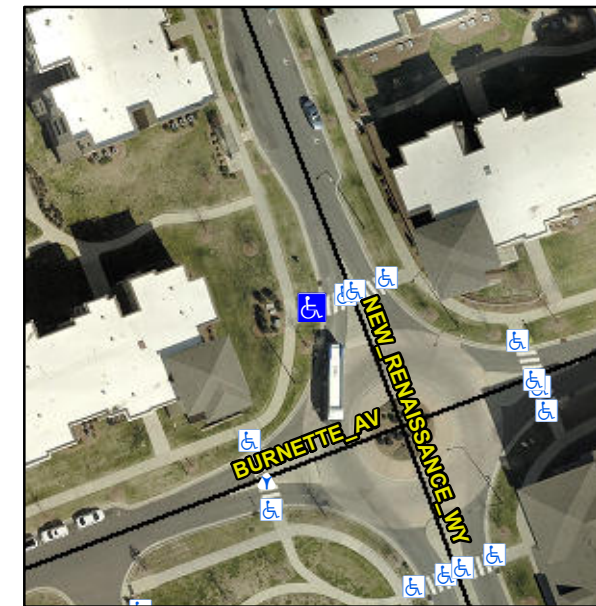
Compliance	Description	Data	Compliance	Description	Data
N/A	Ramp Length (in)	135.0	N/A	Grade Break?	N/A
Yes	Ramp Width (in)	70.0	N/A	Grade Break Slope (%)	0.0
Yes	Ramp Slope (%)	6.4	N/A	Grade Break XSlope (%)	0.0
No	Ramp XSlope (%)	3.2			
N/A	Flare Type LT	N/A	N/A	Flare Type RT	N/A
N/A	Flare Slope LT (%)	N/A	N/A	Flare Slope RT (%)	0.0
N/A	Flare Traversable LT?	N/A	N/A	Flare Traversable RT?	N/A
N/A	Landing Length (in)	0.0	N/A	DWS Provided?	N/A
N/A	Landing Width (in)	0.0	N/A	DWS Contrast?	N/A
N/A	Landing Slope (%)	0.0	N/A	DWS Length (in)	N/A
N/A	Landing X Slope (%)	0.0	N/A	DWS Full Width?	N/A
N/A	Landing Curb? (Y/N)	N/A	N/A	DWS Offset LT (in)	N/A
N/A	Shared Landing?	N/A	N/A	DWS Offset RT (in)	N/A
N/A	Gutter Ponding?	0.0	N/A	Gutter Slope (%)	N/A
N/A	Gutter Lip Ht (in)	0.0	N/A	Gutter X Slope (%)	N/A
N/A	Painted X Walk1?	Yes		Road Slope (%)	2.8
	X Walk 1 Direction	To NE		Road X Slope (%)	2.1
	X Walk 1 Width (in)	121.0		Clear Space?	N/A

X Walk 1 Slope (%)	2.8	N/A	Clear Space to XWalk (in)	N/A
	X Walk 1 X Slope (%)	2.1	N/A	Storm Grate/Utility Hazard?	N/A
N/A	Ramp inside XWalk1?	Yes		Storm Grate/Utility Type	
N/A	Any Obstructions?	N/A			N/A
	Obstruction Type		Yes	Surface Condition? (G/P)	Good
			N/A	Curb Slope (%)	4.1

Possible Solutions:

Remove & Replace Entire Ramp.

R304.5.3

\$ 1600.00
