# Access Compliance Report

## Public Rights-of-Way

### (Curb Ramps)

Intersection ID: 48198	Main Street: RIVERGATE_PY	Cross Street: S_TRYON_ST	Location: NE
ADA ID: 0122A75C519A	Ramp Type: Perp	Initial Pass/Fail: Fail	Overall Compliance: No
Severity Score: 25			
Codes/Mitigation Info/Possible Solution		Field Measurements/Component Compliance

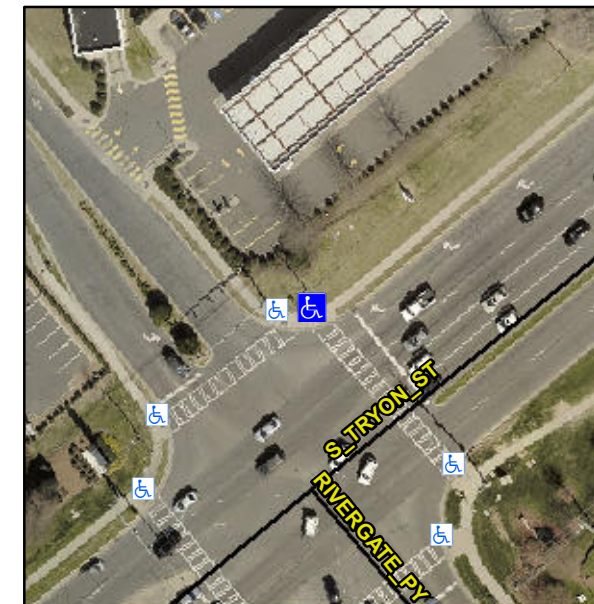
**Not Found, R304.2.2, R304.5.3**

Compliance	Description	Data	Compliance	Description	Data
N/A	Ramp Length (in)	89.0	No	Ramp Slope (%)	8.9
Yes	Ramp Width (in)	48.0	No	Ramp XSlope (%)	5.6
N/A	Flare Type LT	N/A	N/A	Flare Type RT	N/A
N/A	Flare Slope LT (%)	N/A	N/A	Flare Slope RT (%)	N/A
N/A	Flare Traversable LT?	N/A	N/A	Flare Traversable RT?	N/A
N/A	Landing Length (in)	N/A	N/A	DWS Provided?	N/A
N/A	Landing Width (in)	N/A	N/A	DWS Contrast?	N/A
N/A	Landing Slope (%)	N/A	N/A	DWS Length (in)	N/A
N/A	Landing X Slope (%)	N/A	N/A	DWS Full Width?	N/A
N/A	Landing Curb? (Y/N)	N/A	N/A	DWS Offset (in)	N/A
N/A	Shared Landing?	N/A			
N/A	Gutter Ponding?	N/A	N/A	Gutter Slope (%)	N/A
N/A	Gutter Lip Ht (in)	N/A	N/A	Gutter X Slope (%)	N/A
N/A	Painted X Walk1?	Yes	N/A	Painted X Walk2?	N/A
	X Walk 1 Direction	To SE		X Walk 2 Direction	N/A
N/A	X Walk 1 Width (in)	112.0	N/A	X Walk 2 Width (in)	N/A
	X Walk 1 Slope (%)	0.7		X Walk 2 Slope (%)	N/A
	X Walk 1 X Slope (%)	3.3		X Walk 2 X Slope (%)	N/A

N/A	Ramp inside XWalk1?	Yes	N/A	Ramp inside XWalk2?	N/A
	Road Slope (%)	N/A	N/A	Clear Space?	N/A
	Road X Slope (%)	N/A	N/A	Clear Space to XWalk (in)	N/A
N/A	Any Obstructions?	N/A	N/A	Storm Grate/Utility Hazard?	N/A
	Obstruction Type			Storm Grate/Utility Type	
		N/A			N/A
			Yes	Surface Condition? (G/P)	Good

**Remove & Replace Entire Ramp.**

Total Cost: \$ 1850.00
