Access Compliance Report

Public Rights-of-Way

(Curb Ramps)

Intersection ID: 21751	Main Street: BRITTON_WOOD_PL	Cross Street: POPLAR_FOREST_DR	Location: SW
ADA ID: 012B6B34295A	Ramp Type: BlendTrans2	Initial Pass/Fail: Fail	Overall Compliance: No
Severity Score: 10			
Codes/Mitigation Info/Possible Solution		Field Measurements/Component Compliance

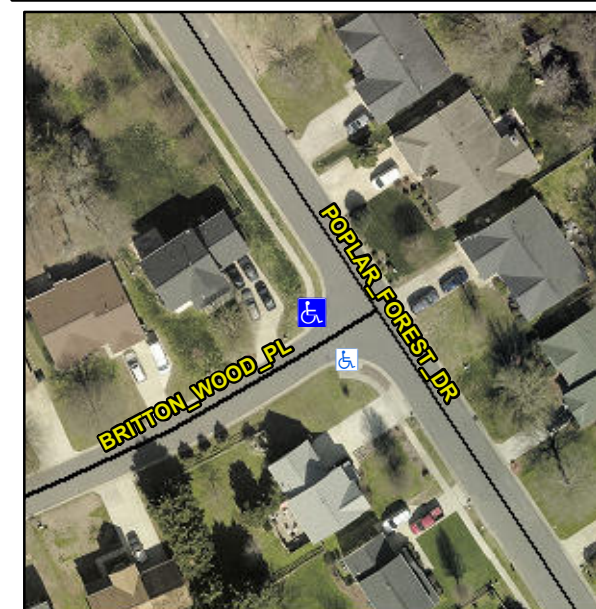
Compliance	Description	Data	Compliance	Description	Data
N/A	Ramp Length (in)	96.0	Yes	BlendTrans Slope (%)	3.0
No	Ramp Width (in)	39.0	No	BlendTrans XSlope (%)	4.0
N/A	Flare Type LT	N/A	N/A	Flare Type RT	N/A
N/A	Flare Slope LT (%)	N/A	N/A	Flare Slope RT (%)	N/A
N/A	Flare Traversable LT?	N/A	N/A	Flare Traversable RT?	N/A
N/A	Landing Length (in)	N/A	N/A	DWS Provided?	N/A
N/A	Landing Width (in)	N/A	N/A	DWS Contrast?	N/A
N/A	Landing Slope (%)	N/A	N/A	DWS Length (in)	N/A
N/A	Landing X Slope (%)	N/A	N/A	DWS Full Width?	N/A
N/A	Landing Curb? (Y/N)	N/A	N/A	DWS Offset (in)	N/A
N/A	Shared Landing?	N/A			
N/A	Gutter Ponding?	N/A	N/A	Gutter Slope (%)	N/A
N/A	Gutter Lip Ht (in)	N/A	N/A	Gutter X Slope (%)	N/A
N/A	Painted X Walk1?	No	N/A	Painted X Walk2?	No
	X Walk 1 Direction	To SE		X Walk 2 Direction	To NE
	X Walk 1 Width (in)	N/A		X Walk 2 Width (in)	N/A
	X Walk 1 Slope (%)	2.4		X Walk 2 Slope (%)	4.7
	X Walk 1 X Slope (%)	3.7		X Walk 2 X Slope (%)	3.2

N/A	Ramp inside XWalk1?	N/A	N/A	Ramp inside XWalk2?	N/A
	Road Slope (%)	3.0		Clear Space?	N/A
	Road X Slope (%)	4.4	N/A	Clear Space to XWalk (in)	N/A
N/A	Any Obstructions?	N/A	N/A	Storm Grate/Utility Hazard?	N/A
	Obstruction Type			Storm Grate/Utility Type	
		N/A			N/A
			Yes	Surface Condition? (G/P)	Good
			N/A	Curb Slope (%)	0.9

Remove & Replace Curb Ramp With Two New Directional Ramps or Equivalent.

R304.5.1, R304.5.3
