# Access Compliance Report

## Public Rights-of-Way

### (Curb Ramps)

Intersection ID: 49390	Main Street: DISTRICT_DR	Cross Street: SHORTHORN_ST	Location: NE
ADA ID: 012C9ABB5339	Ramp Type: Perp	Initial Pass/Fail: Fail	Overall Compliance: No
		Severity Score: 10

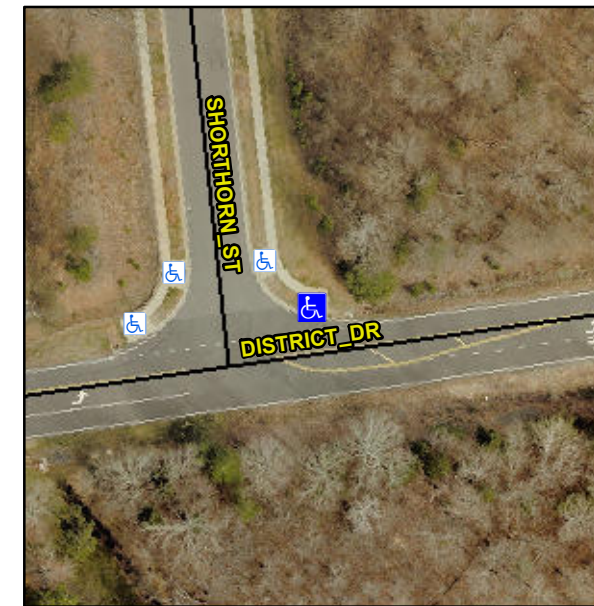
Compliance	Description	Data	Compliance	Description	Data
N/A	Ramp Length (in)	97.0	Yes	Ramp Slope (%)	6.1
No	Ramp Width (in)	47.0	Yes	Ramp XSlope (%)	3.1
N/A	Flare Type LT	N/A	N/A	Flare Type RT	N/A
N/A	Flare Slope LT (%)	N/A	N/A	Flare Slope RT (%)	N/A
N/A	Flare Traversable LT?	N/A	N/A	Flare Traversable RT?	N/A
N/A	Landing Length (in)	N/A	N/A	DWS Provided?	N/A
N/A	Landing Width (in)	N/A	N/A	DWS Contrast?	N/A
N/A	Landing Slope (%)	N/A	N/A	DWS Length (in)	N/A
N/A	Landing X Slope (%)	N/A	N/A	DWS Full Width?	N/A
N/A	Landing Curb? (Y/N)	N/A	N/A	DWS Offset (in)	N/A
N/A	Shared Landing?	N/A			
N/A	Gutter Ponding?	N/A	N/A	Gutter Slope (%)	N/A
N/A	Gutter Lip Ht (in)	0.5	N/A	Gutter X Slope (%)	N/A
N/A	Painted X Walk1?	No	N/A	Painted X Walk2?	N/A
	X Walk 1 Direction	To S		X Walk 2 Direction	N/A
N/A	X Walk 1 Width (in)	N/A	N/A	X Walk 2 Width (in)	N/A
	X Walk 1 Slope (%)	3.6		X Walk 2 Slope (%)	N/A
	X Walk 1 X Slope (%)	8.1		X Walk 2 X Slope (%)	N/A

N/A	Ramp inside XWalk1?	N/A	N/A	Ramp inside XWalk2?	N/A
	Road Slope (%)	8.1	N/A	Clear Space?	N/A
	Road X Slope (%)	3.6	N/A	Clear Space to XWalk (in)	N/A
N/A	Any Obstructions?	N/A	N/A	Storm Grate/Utility Hazard?	N/A
	Obstruction Type			Storm Grate/Utility Type	
		N/A			N/A
			Yes	Surface Condition? (G/P)	Good

**Remove & Replace Entire Ramp.**
