# Access Compliance Report

## Public Rights-of-Way

### (Curb Ramps)

Intersection ID: 10025500	Main Street: E MARTIN LUTHER KING JR BLVD	Cross Street: N/A	Location: W
ADA ID: 013A8851399C	Ramp Type: Directional	Initial Pass/Fail: Fail	Overall Compliance: No
Codes/Mitigation Info/Possible Solution		Field Measurements/Component Compliance	
Severity Score: 13.75

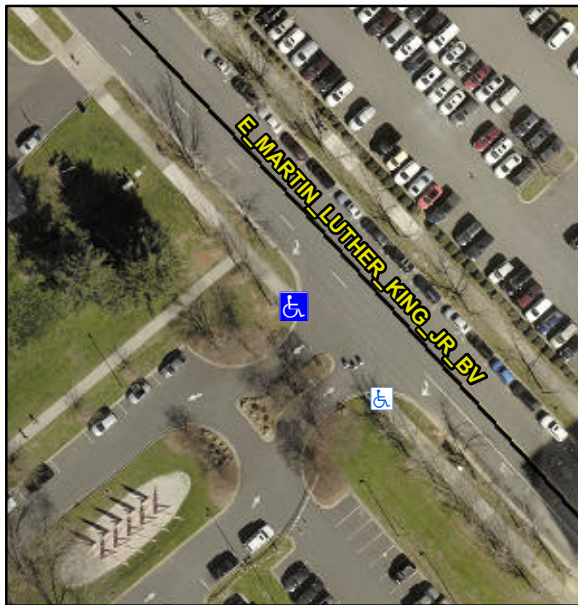
Compliance	Description	Data	Compliance	Description	Data
N/A	Ramp Length (in)	87.0	N/A	Grade Break?	N/A
Yes	Ramp Width (in)	96.0	N/A	Grade Break Slope (%)	0.0
No	Ramp Slope (%)	8.6	N/A	Grade Break XSlope (%)	0.0
Yes	Ramp XSlope (%)	2.1			
N/A	Flare Type LT	N/A	N/A	Flare Type RT	N/A
N/A	Flare Slope LT (%)	N/A	N/A	Flare Slope RT (%)	0.0
N/A	Flare Traversable LT?	N/A	N/A	Flare Traversable RT?	N/A
N/A	Landing Length (in)	0.0	N/A	DWS Provided?	N/A
N/A	Landing Width (in)	0.0	N/A	DWS Contrast?	N/A
N/A	Landing Slope (%)	0.0	N/A	DWS Length (in)	N/A
N/A	Landing X Slope (%)	0.0	N/A	DWS Full Width?	N/A
N/A	Landing Curb? (Y/N)	N/A	N/A	DWS Offset LT (in)	N/A
N/A	Shared Landing?	N/A	N/A	DWS Offset RT (in)	N/A
N/A	Gutter Ponding?	0.0	N/A	Gutter Slope (%)	N/A
N/A	Gutter Lip Ht (in)	0.0	N/A	Gutter X Slope (%)	N/A
N/A	Painted X Walk1?	No		Road Slope (%)	3.4
	X Walk 1 Direction	To SE		Road X Slope (%)	3.4
	X Walk 1 Width (in)	N/A		Clear Space?	N/A

X Walk 1 Slope (%)	3.4	N/A	Clear Space to XWalk (in)	N/A
	X Walk 1 X Slope (%)	3.4	N/A	Storm Grate/Utility Hazard?	N/A
N/A	Ramp inside XWalk1?	N/A		Storm Grate/Utility Type	
N/A	Any Obstructions?	N/A			N/A
	Obstruction Type		Yes	Surface Condition? (G/P)	Good
			N/A	Curb Slope (%)	7.7

Possible Solutions:

**Remove & Replace Entire Ramp.**
